**Summer Session of the 25th Navajo Nation Council
July 17, 2023**

**Report on the Navajo Nation Washington Embassy – 11 D Property
Provided by Justin Ahasteen, Executive Director, Navajo Nation Washington Office**

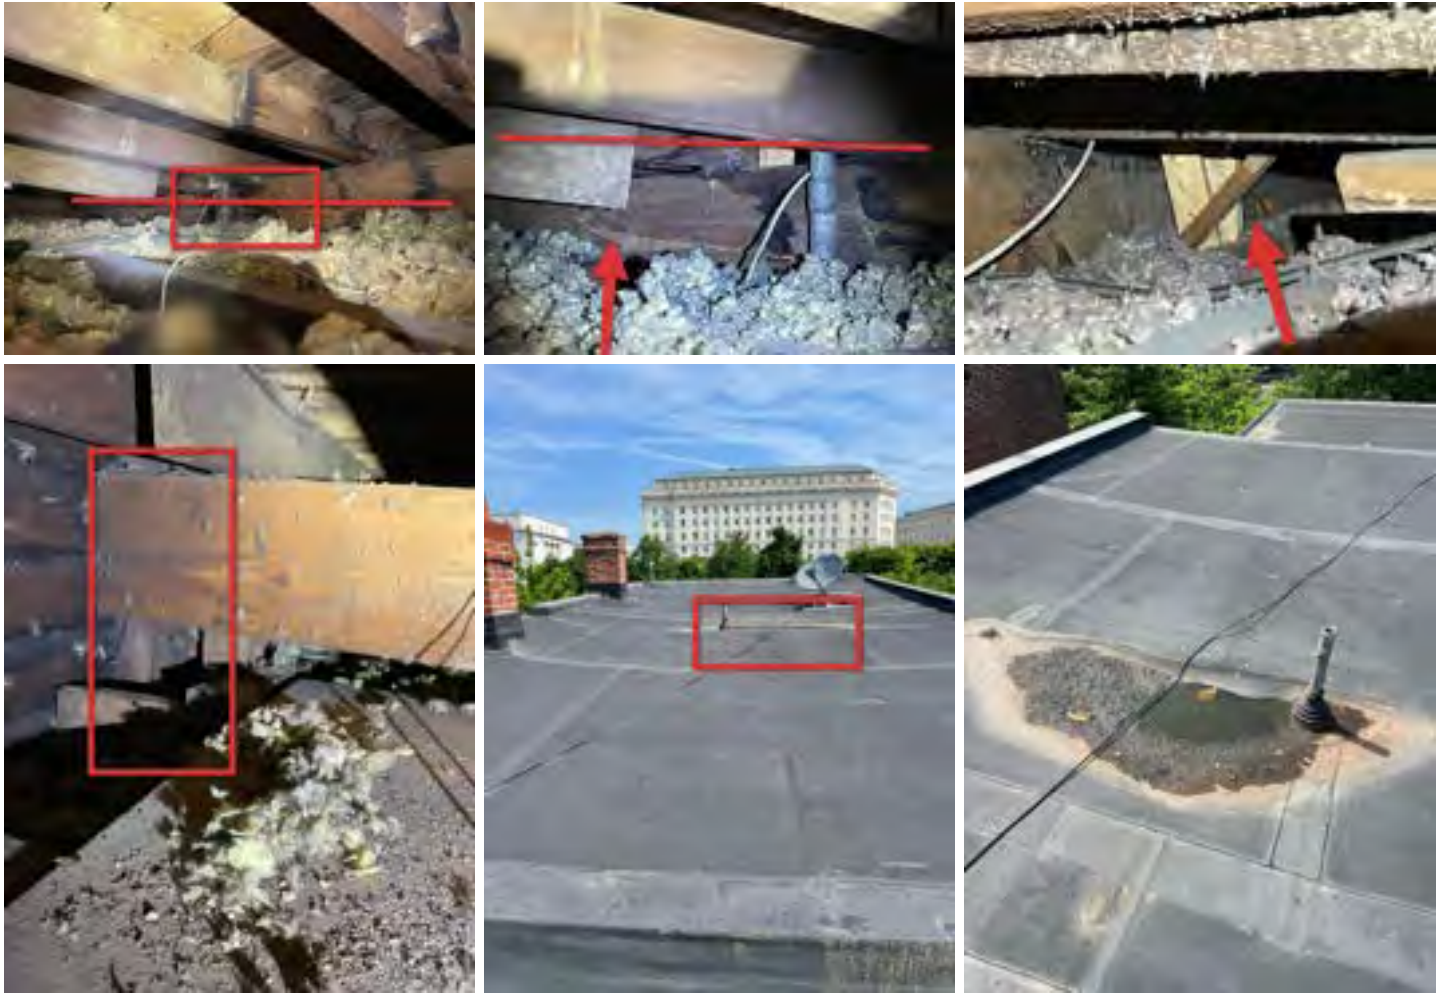
2.4.1 Penetrations and Flashing

TEMPORARY ROOF FLASHING

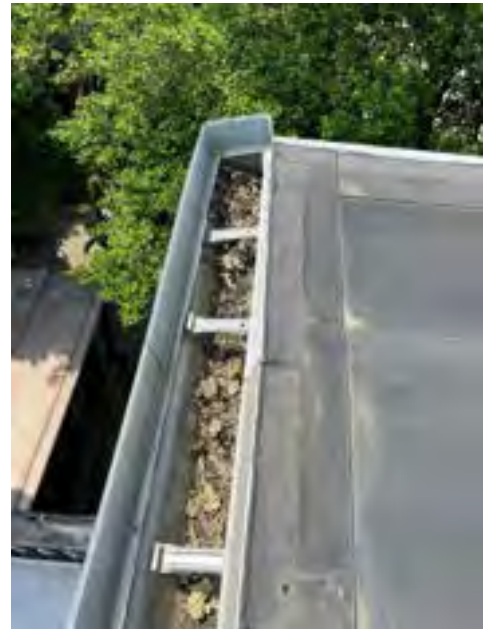
2.5.1 Edges and Drainage

CLOGGED GUTTERS

There are signs that your gutters are frequently overflowing, and locations where the roofing material may extend too far over the gutters. If you are struggling to manage the water flow from your roof do not install debris management systems—like gutter guards, gutter shields, or gutter helmets, but instead opt for increasing the size of your gutters and downspouts.

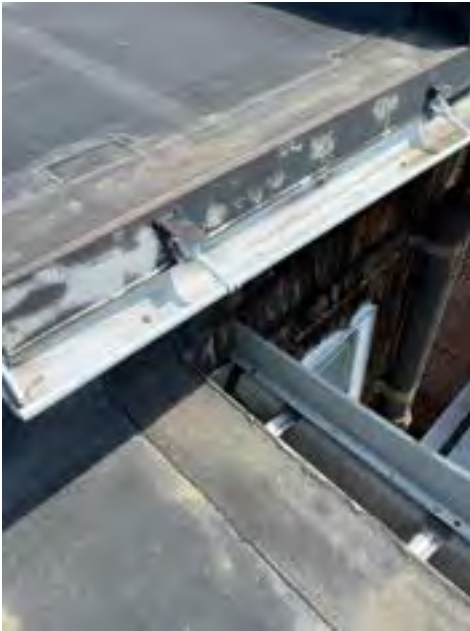
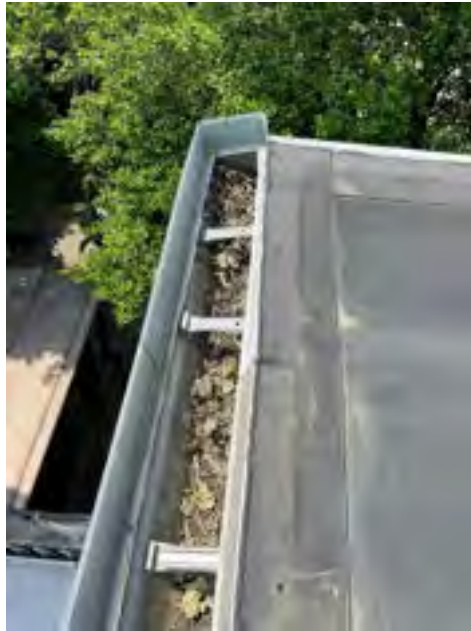
2.5.2 Main House Roof and Drainage - Edges and Drainage: Loose Gutter

Secure the loose gutter in a manner that will maintain a slope that directs the water to the downspout

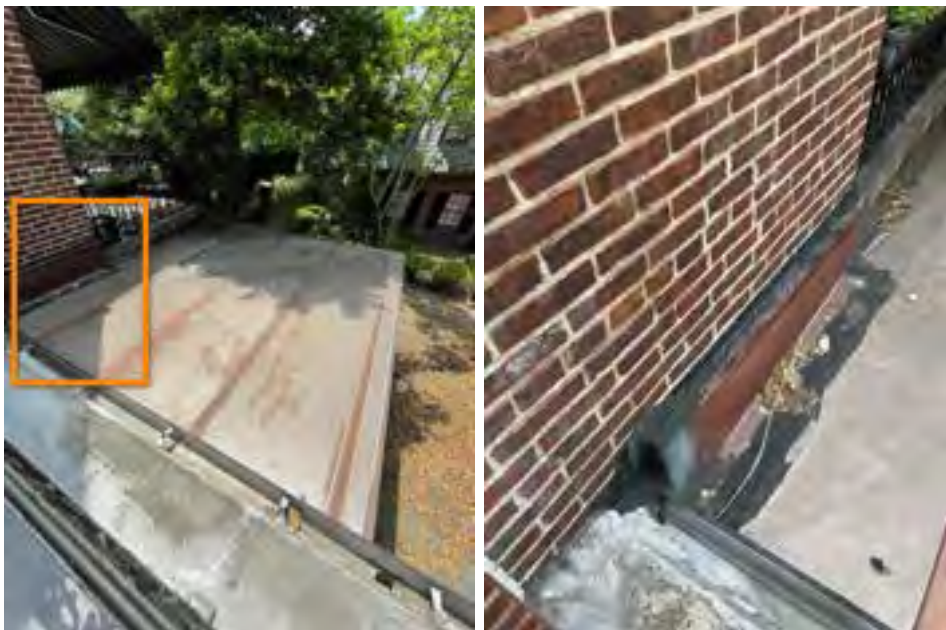
2.5.2 Edges and Drainage

LOOSE GUTTER

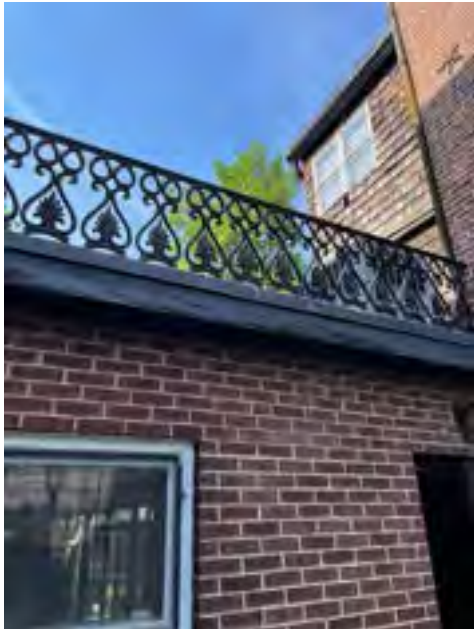
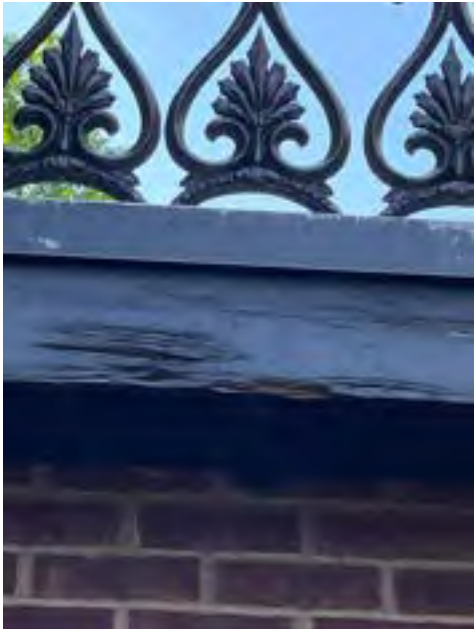
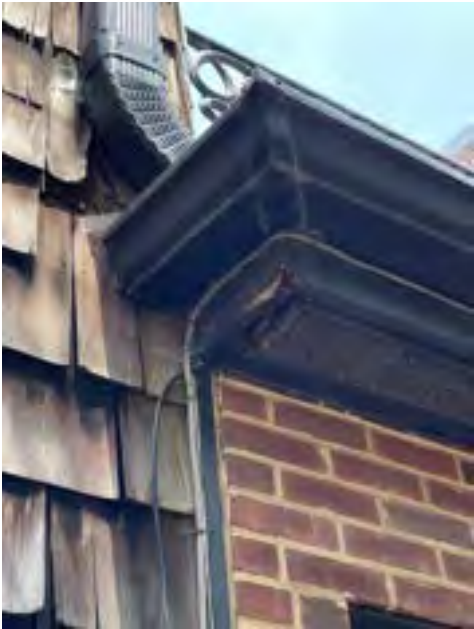
3.5.1 Ground-level Addition Roof and Drainage - Edges and Drainage: Deteriorated Fascia

Repair or replace deteriorated fascia boards and securely reattach the gutters with the proper slope.

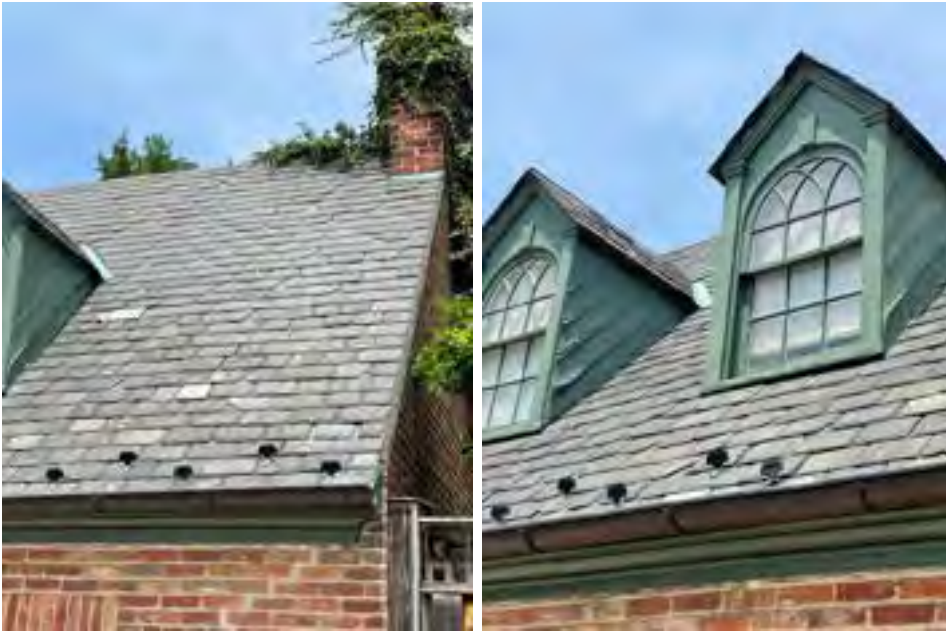
4.3.2 Surface Materials and Features

VINE GROWTH ON ROOFING MATERIALS

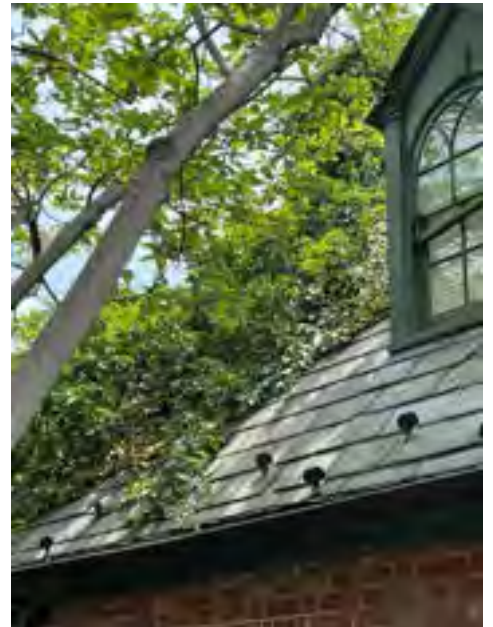
3.5.1 Edges and Drainage

DETERIORATED FASCIA

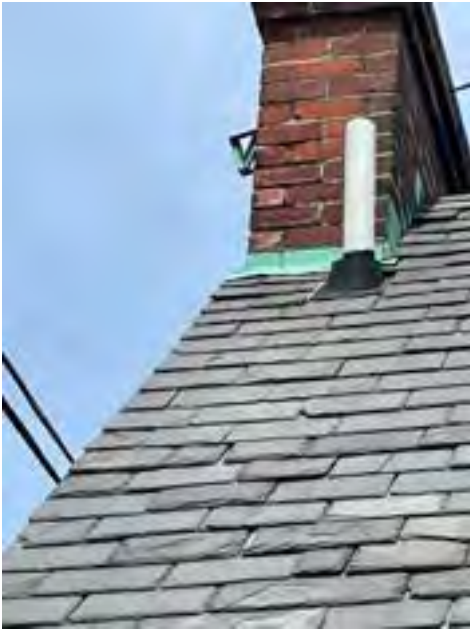
4.3.4 Surface Materials and Features

DAMAGED DORMER SIDING

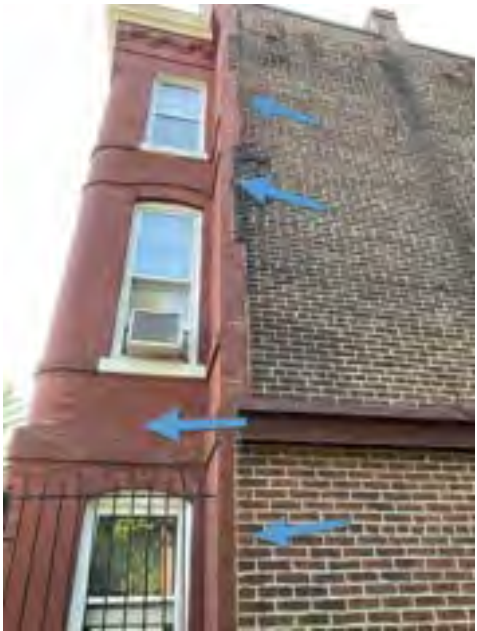
5.2.3 Siding

DETERIORATED SIDING AND SHEATHING

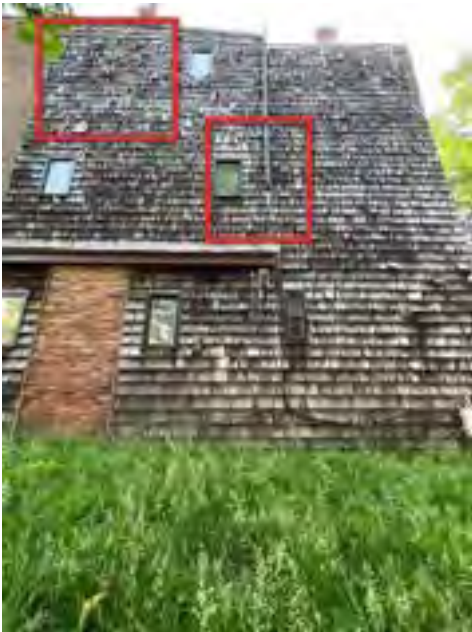
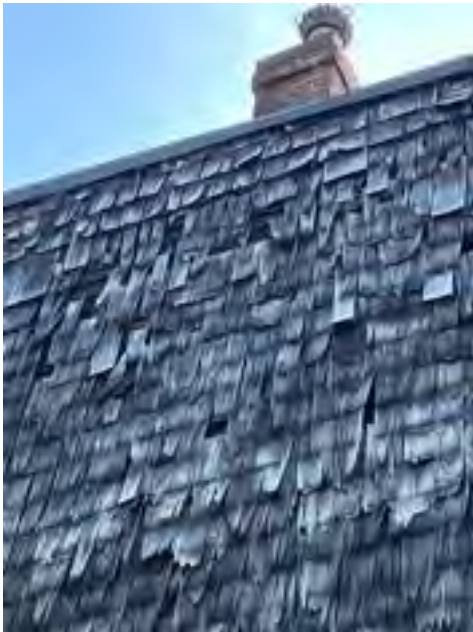
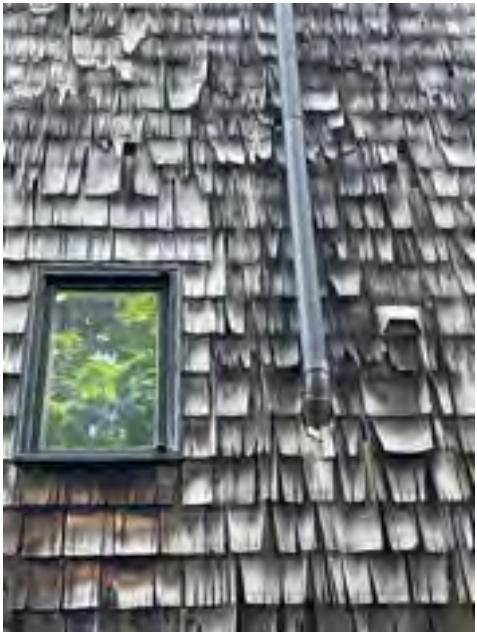
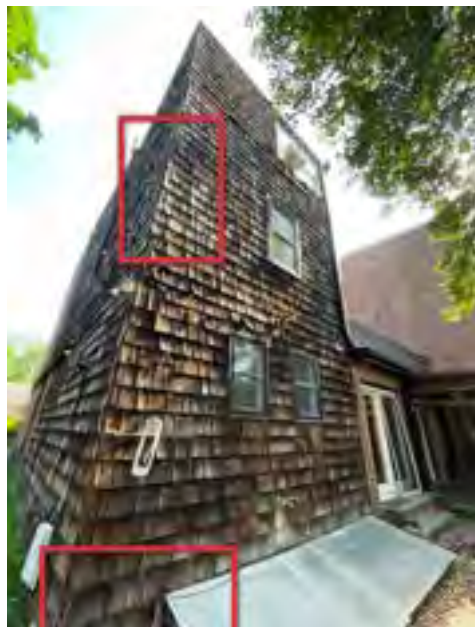
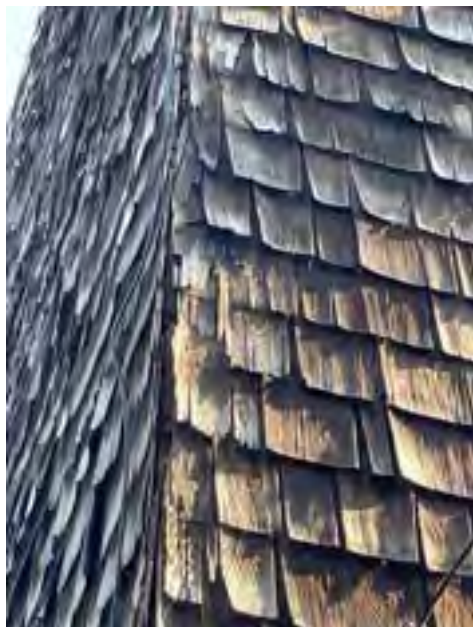
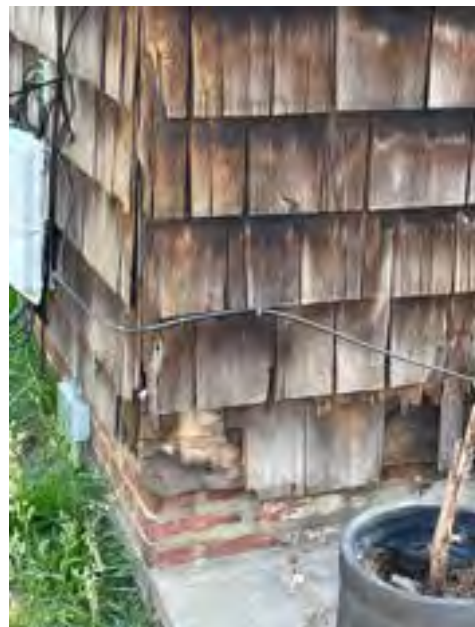
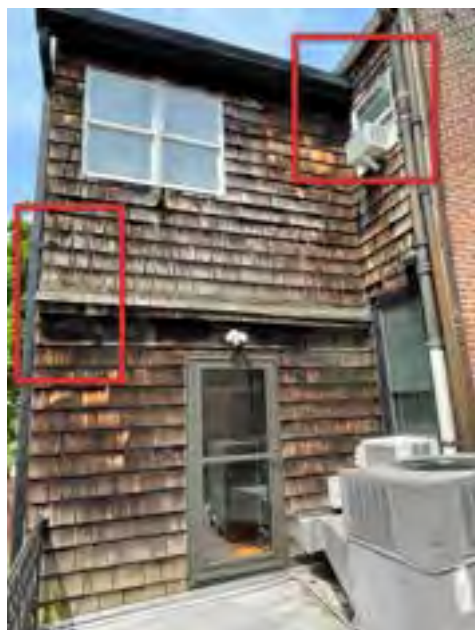
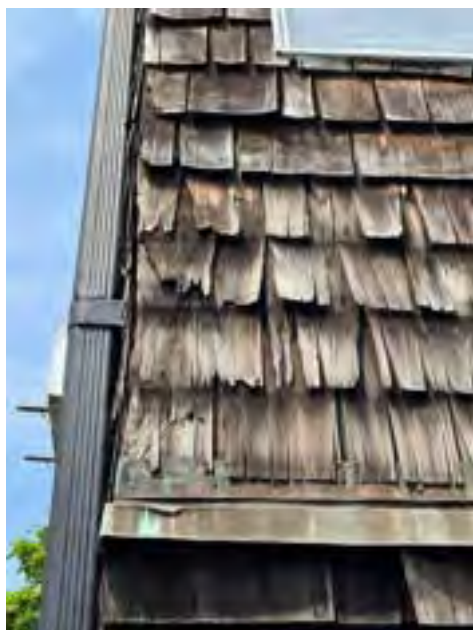
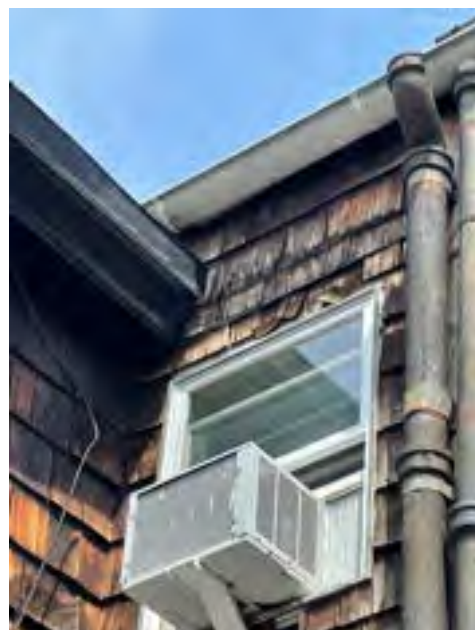
5.2.3 Building Exterior - Siding: Deteriorated Siding and Sheathing

Remove the deteriorated cedar shingles from the west, south, and east sides of the home, replace any deteriorated sheathing, install a water resistant exterior barrier (for example Tyvek), install new siding, and seal all of the gaps around any remaining penetrations and between siding materials.

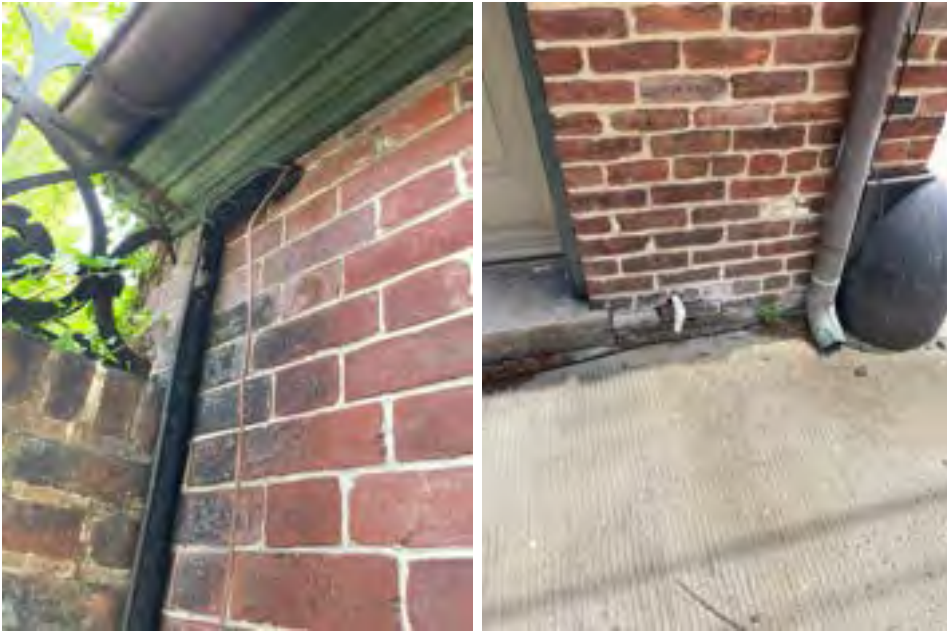
5.3.2 Penetrations, Caulking, and Flashing

UNIDENTIFIABLE SIDING PENETRATION

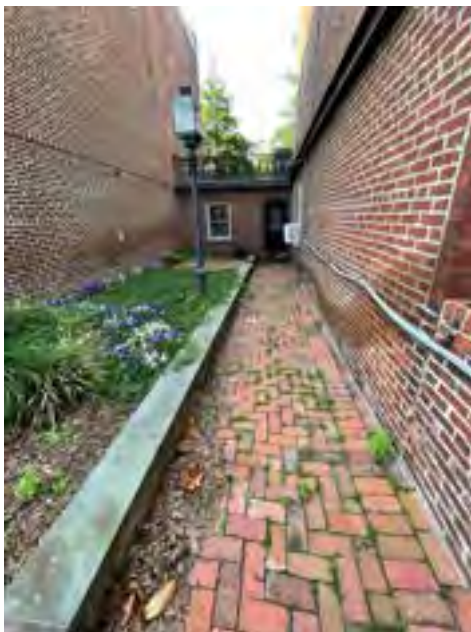
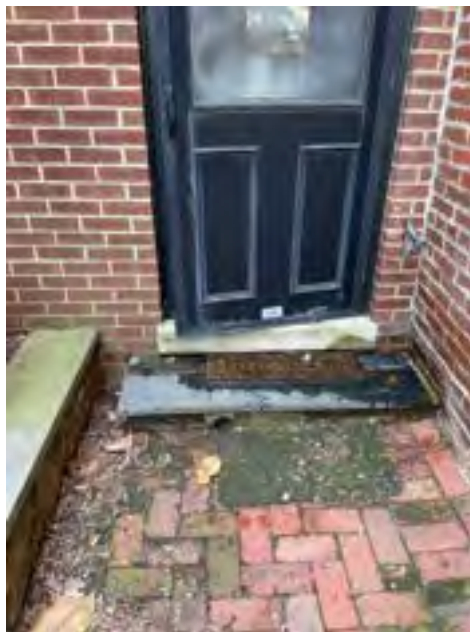
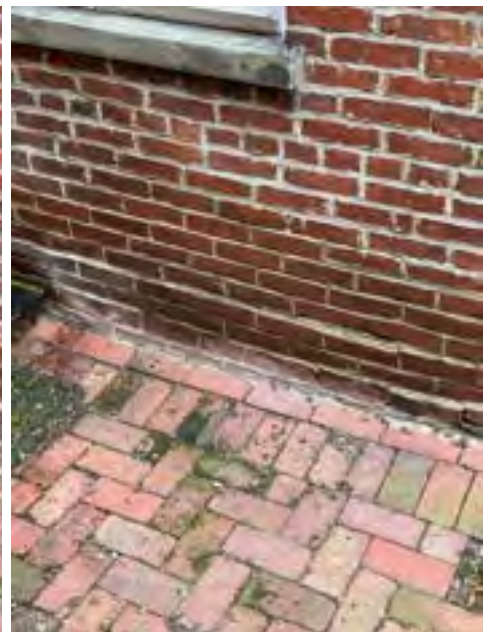
6.3.1 Downspouts, Grading, and Drainage

Surface of the Building Lot is Below Neighboring Properties, Outdoor Living Space Slopes Toward the Home
Correct the negative grading at the side of the house to direct water either toward an underground drain, into a swale, or off of the property.

The grade around the home (including driveways and walkways) should slope away from the home a minimum of 6" for the first 10' away from the foundation or into a swale. A "swale" is a valley-like, v-shaped imprint in the ground that routes water off of the property.

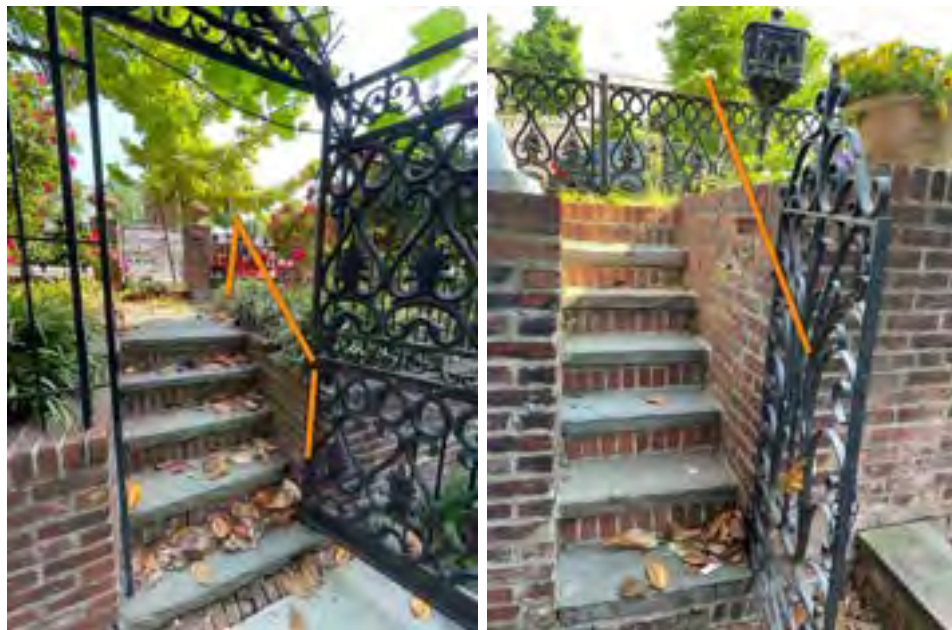
6.4.1 Walkways, Stairs, and Railings

MISSING EXTERIOR HANDRAIL

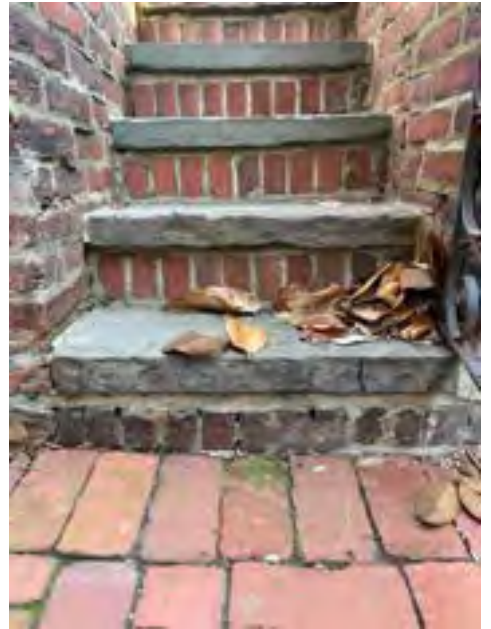
6.4.2 Walkways, Stairs, and Railings

NON-STANDARD EXTERIOR STAIRWAY DIMENSIONS

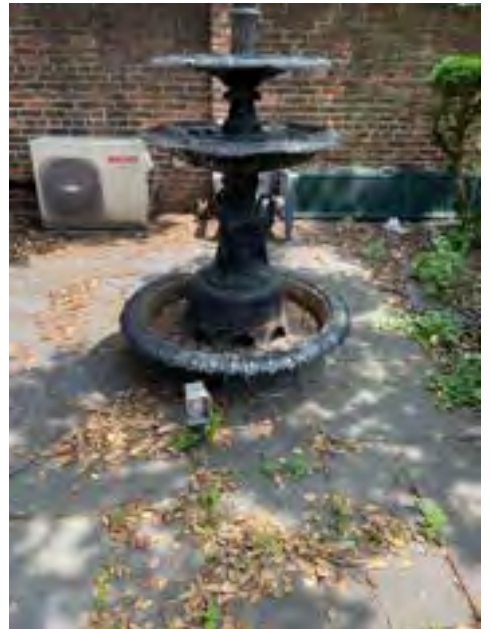
6.6.1 Water Features, Irrigation, and Pools

NON-FUNCTIONAL FOUNTAIN

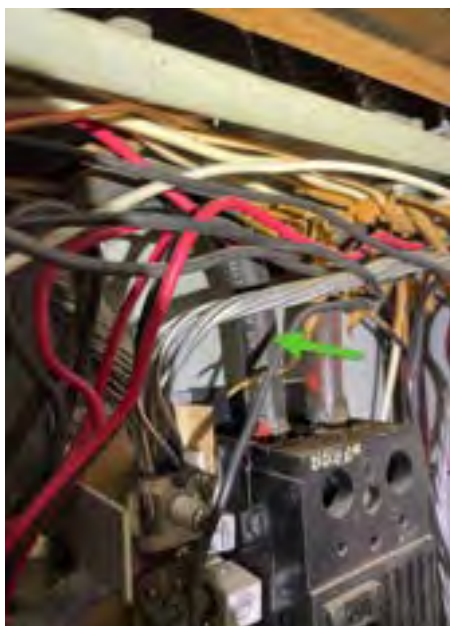
General Electrical System: Unused Locations in the Electrical Panel

Usage Currently Exceeds the Design Limitations of the Panel Box

Given the size of the electrical supply and the condition of the materials in the electrical system, an upgrade may be necessary for you to expand your electrical usage.

Heavy-ups generally begin when homeowners acquire a permit from their municipality for the upgrade, then replace the service entrance cable, primary overcurrent device (aka the main breaker), electrical service panel (main panel), and any antiquated connections in the branch wiring.

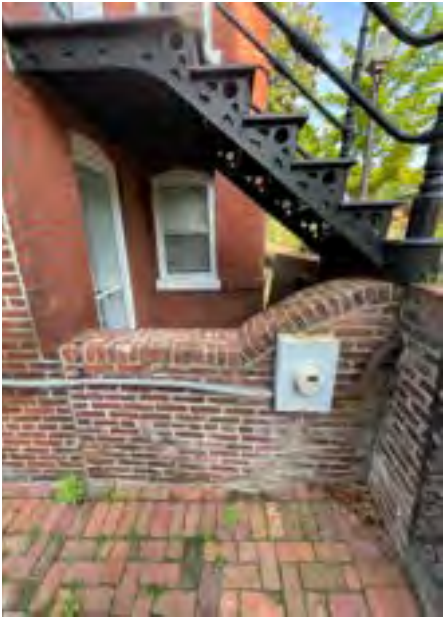
Incoming Electrical Service: Visible Grounding
Plumbing

Main Panel & Overcurrent Devices : Location
Basement, Living Room

Incoming Electrical Service: Incoming Conductors
Braided Aluminum

Main Panel & Overcurrent Devices : Labeling
Partial

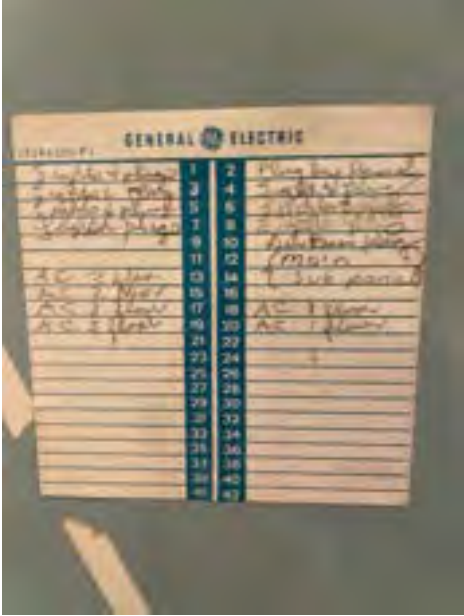
Main Panel & Overcurrent Devices : Primary Electrical Service Overcurrent Protection Rating
200 AMP

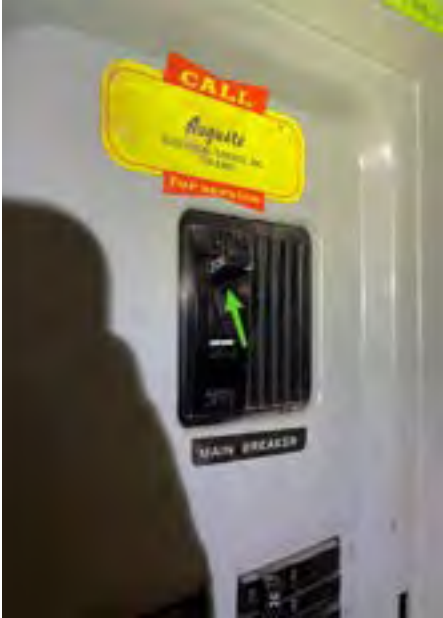
Main Panel & Overcurrent Devices : Primary Electrical Service Overcurrent Type
Main Breaker

Wiring, Receptacles, & Fixtures: General Conductor Material
Copper, Copper Coated w/ Aluminum, Braided Aluminum

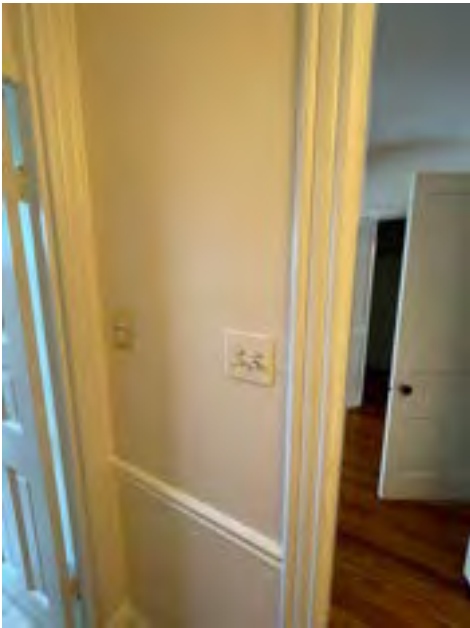
Wiring, Receptacles, & Fixtures: Knob-and-Tube Wiring Suggested by Outdated Switch Style

Consult an electrician to evaluate the wiring providing power to the alternate push-button switches. Although it is not conclusive, this style of switch in a home of this age highly suggests that knob-and-tube wiring is present and providing electricity to fixtures via jury-rigged junctions.

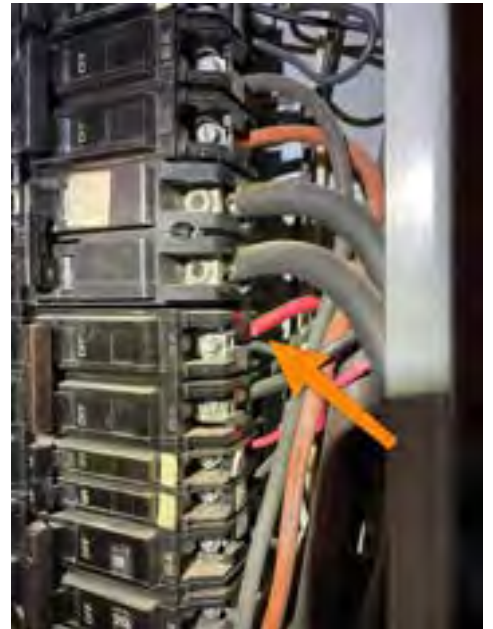
8.3.2 Main Panel & Overcurrent Devices

MULTI-TAPPED BREAKER

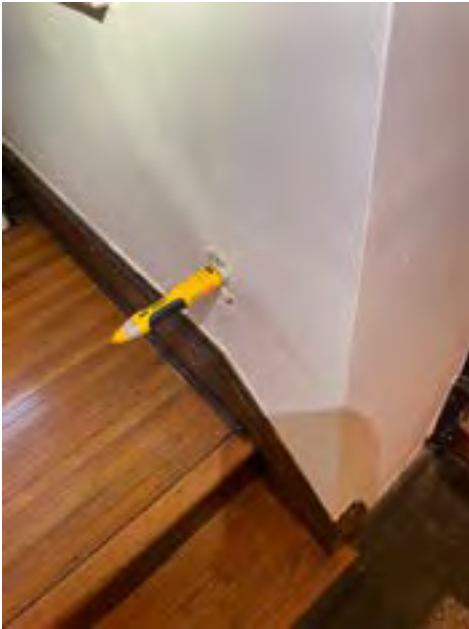
8.4.2 Wiring, Receptacles, & Fixtures

MISSING GFCI PROTECTION

Create the missing GFCI (Ground Fault Circuit Interrupter) protection for all 15- and 20-amp receptacles at the noted locations.

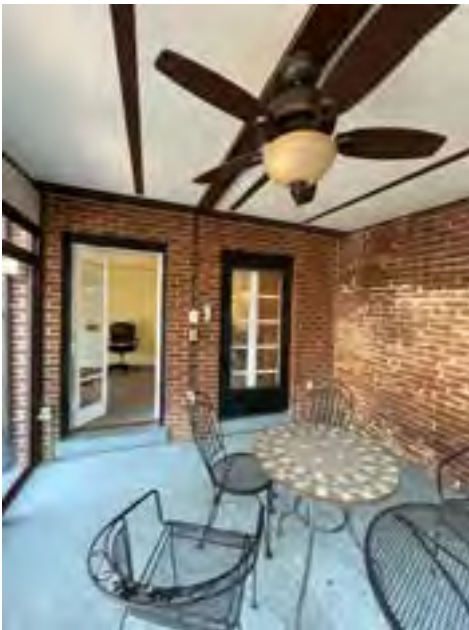
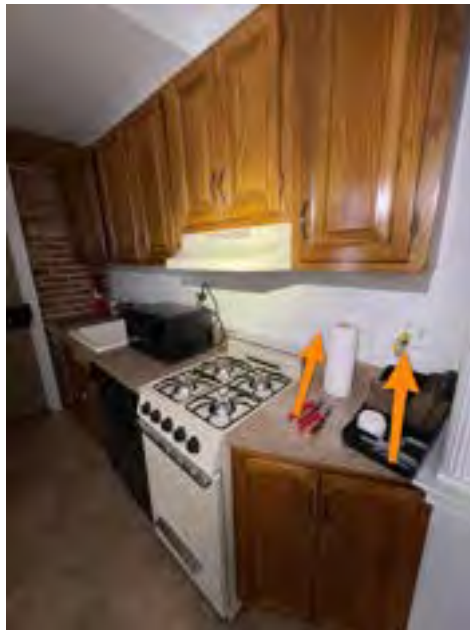
8.4.3 Wiring, Receptacles, & Fixtures

FAULTY GFCI PROTECTION

Correct the faulty GFCI protection at the noted locations.

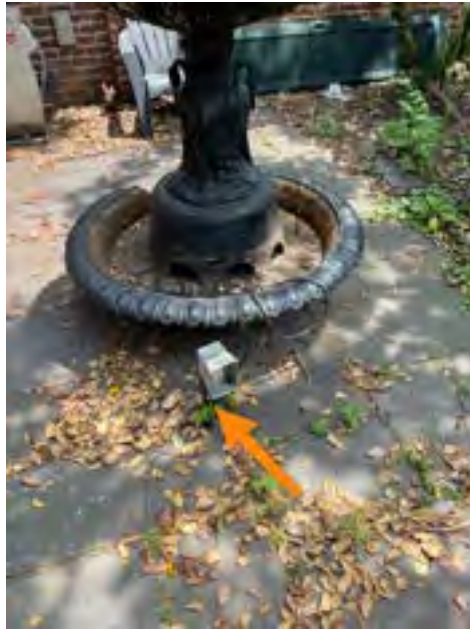
8.4.4 Wiring, Receptacles, & Fixtures

UNPROTECTED WIRING

Loose Connection, Exposed Wire

Repair, abandon and remove, or properly conceal the unprotected wiring in a sealed junction box attached to a solid surface.

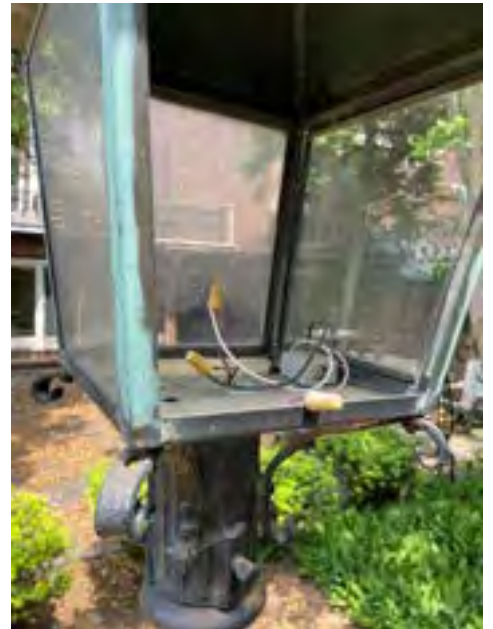
8.4.1 Wiring, Receptacles, & Fixtures

INCORRECTLY WIRED OUTLET

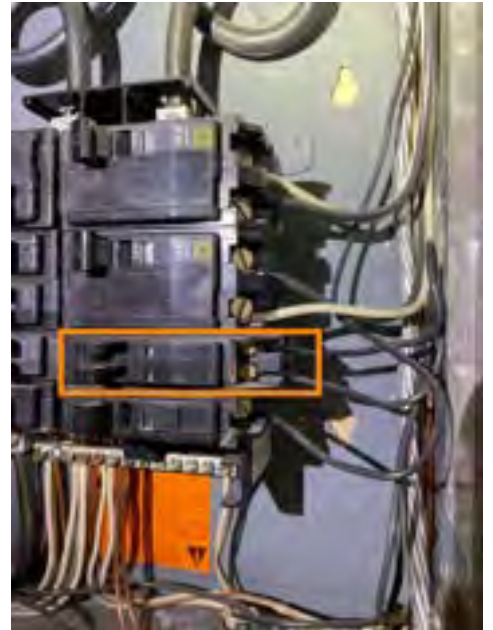
8.5.1 Sub-Panels

OVER-SIZED SUB-PANEL BREAKER

Remove the oversized 20amp breakers and install 15amp breakers appropriate for protecting 14gauge wires.

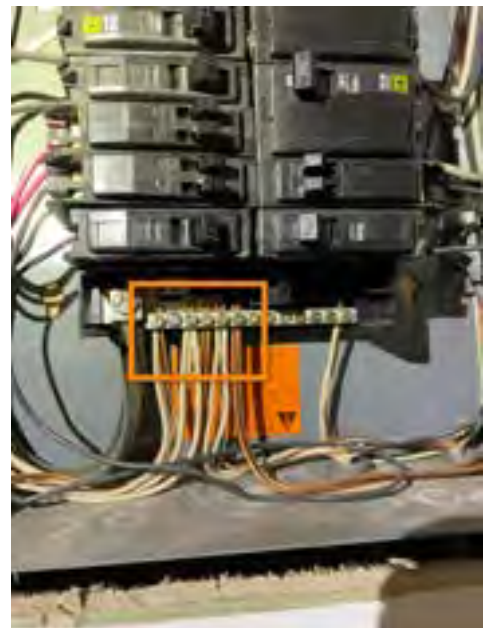
8.5.2 Sub-Panels

DOUBLED SUB-PANEL NEUTRALS

Distribute the neutral wires on the omnibus bar so that there is only one wire under a screw.

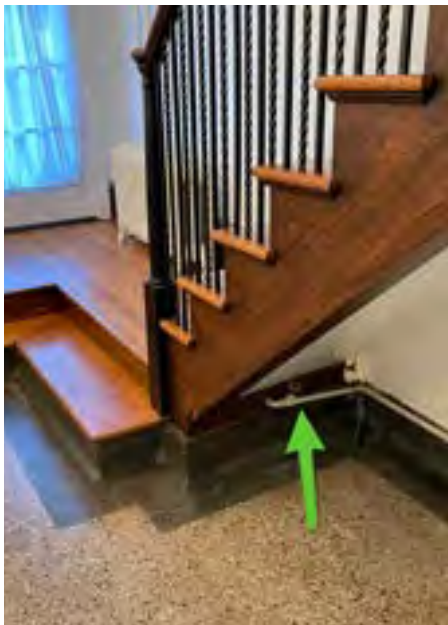
**Water Supply System: Water****Supply Distribution Material**

Copper, Galvanized Steel

Your supply distribution plumbing system appears to contain the galvanized steel plumbing and fittings.

Although *galvanized steel plumbing is not generally considered a health hazard*, the interior of the plumbing corrodes. This corrosion gradually reduces the functional water pressure to branches of the home--which may be inconvenient and can cause severe temperature changes when multiple fixtures are in use simultaneously. Continued buildup of the corrosion will eventually block the flow of water entirely. Furthermore, dislodged corrosion may enter and damage you plumbing supplied appliances, like your water heater, clothes washing machine, refrigerator, etc.

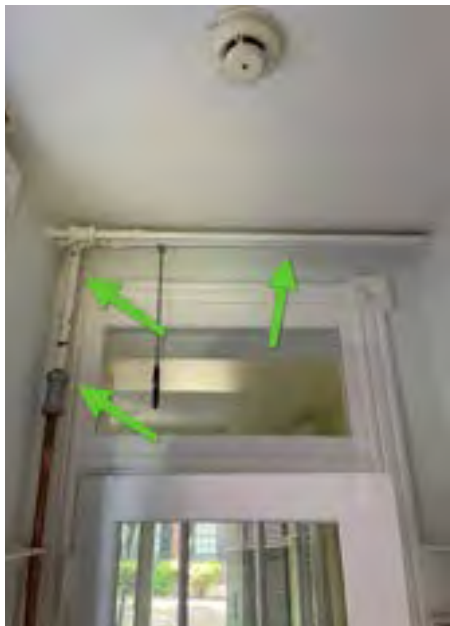
Hot Water System: Water Heater Location

Utility Room/Closet

Hot Water System: Manufacturer & Data Tag

Bradford White

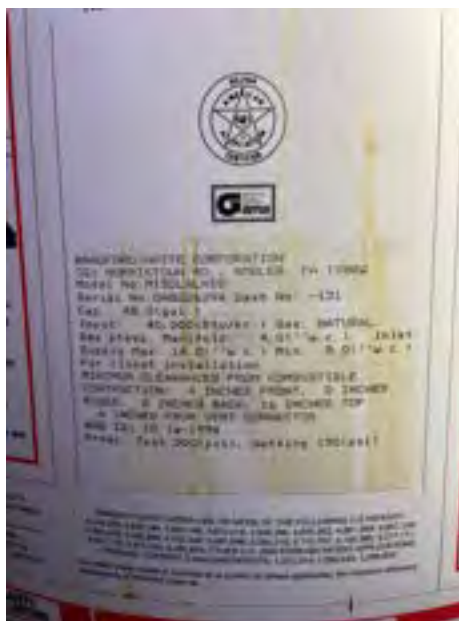
Hot Water System: Age

27 Years

Budget to replace the water heater when it is 15 years old. This is around the point in time when normally installed water heaters start having normal age-related leaks. Even if you have a water heater that currently functions and does not appear to leak, proactive replacement of your water heater can avoid anticipatable losses due to leaks.

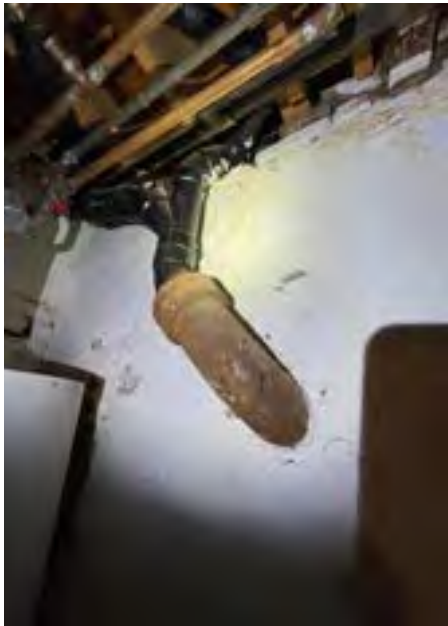
**Waste and Vent System: Internal Waste Plumbing Material**

Plastic, Cast Iron, Exterior Plumbing

Never use corrosive drain cleaners on your plumbing. For clogs, use a plumbing snake or consult a professional.

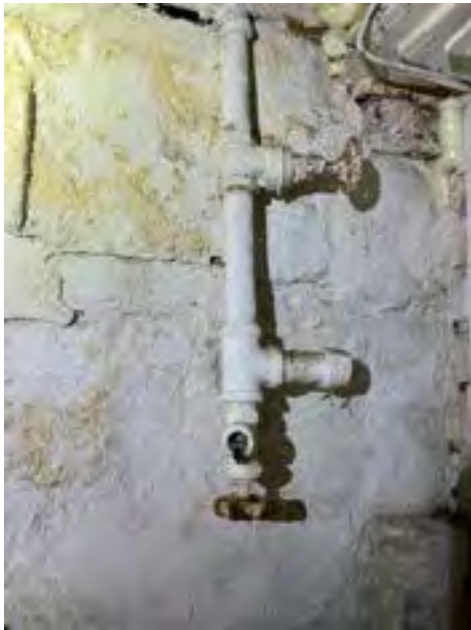
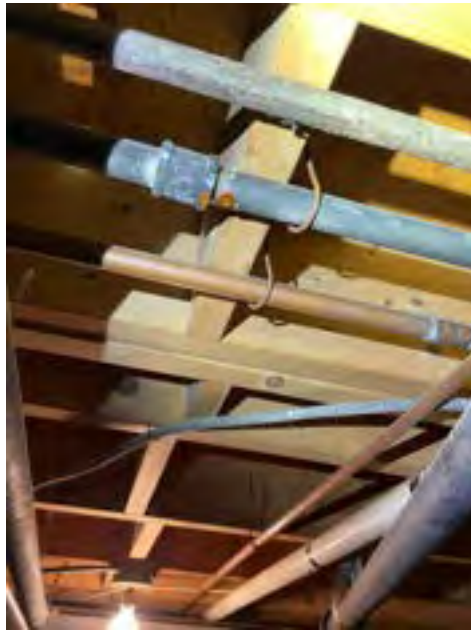
9.2.2 Water Supply System

Galvanic corrosion occurs when dissimilar metals are in contact with each other in the presence of water, and this corrosion can damage materials at the site of the connection, downstream from the connection, and at appliances downstream.

LEAKY WATER DISTRIBUTION PLUMBING COMPONENT

Consult a plumber for evaluation of the connections between dissimilar metals in the distribution plumbing, as well as the condition of the downstream plumbing and appliances. Plumbing replacement, the installation of dielectric unions, and appliance repair may be necessary.

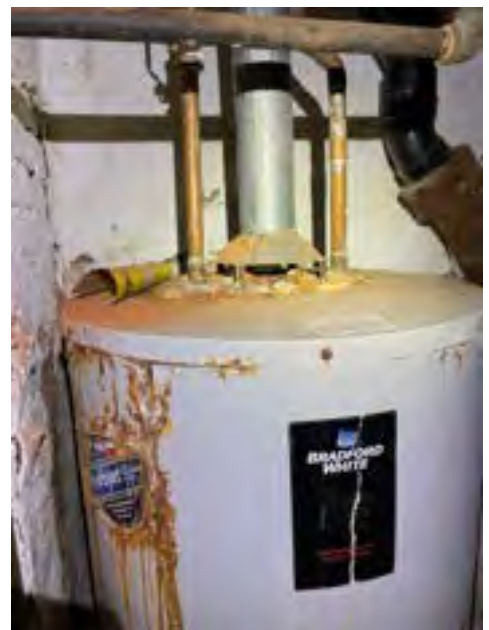
9.3.1 Hot Water System

AGED WATER HEATER WITH FLAWED INSTALLATION

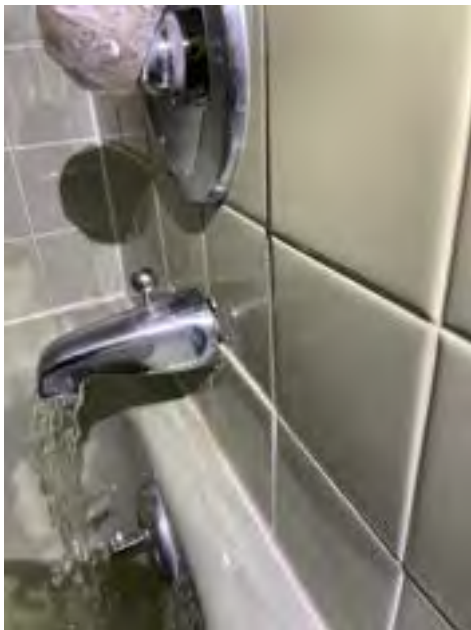
9.5.3 Faucets and Fixtures

DETERIORATED CAULK

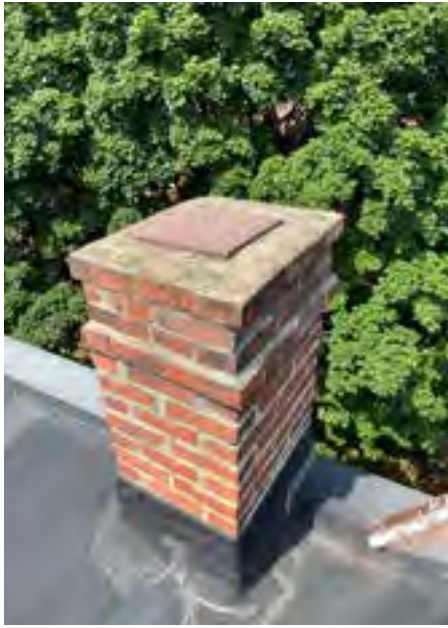
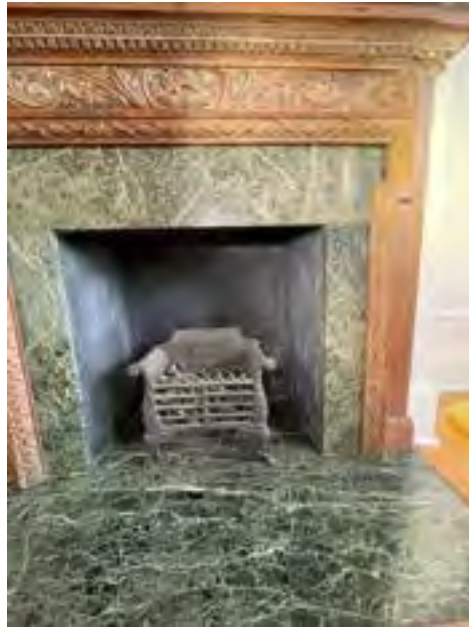
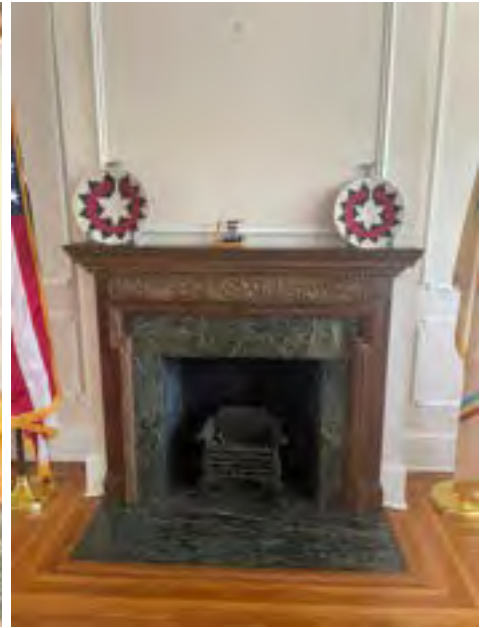
The fireplace is currently decorative feature only due to modifications at the top of the chimney, in the chimney liner, or in the firebox. Consult a fireplace contractor if you wish to use this feature as a wood burning fireplace.

Wood Burning Fireplace and Flue: Firebox Material and Features

Masonry, Andirons

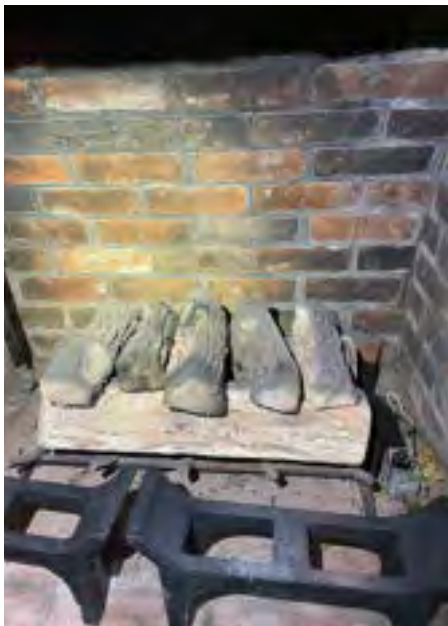
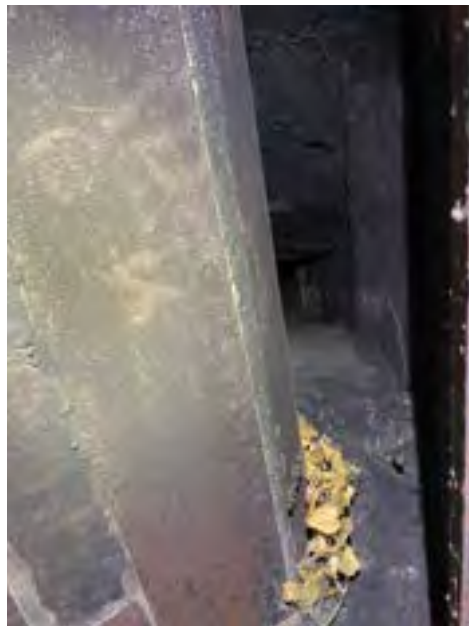
Gas Burning Fireplace: Installation Type

Conventional Fireplace Conversion

Gas Burning Fireplace: Ventilation

Vented Gas Logs

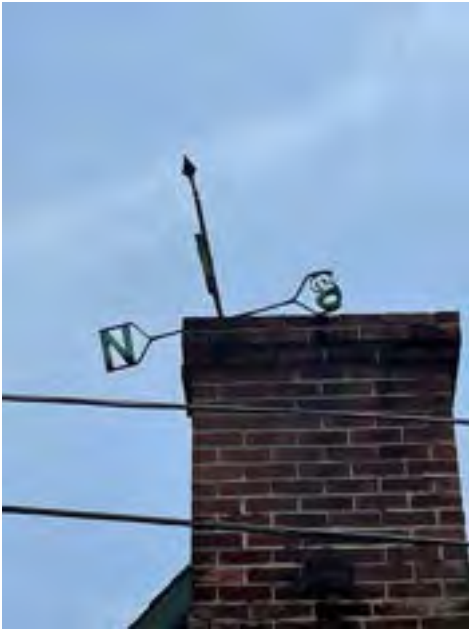
10.6.3 Flue and Chimney Exterior

CHIMNEY DETERIORATION IN THE ATTIC

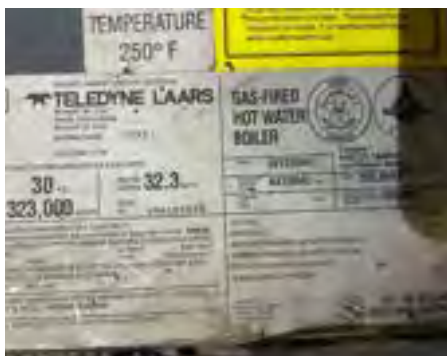
Radiant Heating: Equipment Age

26 Years

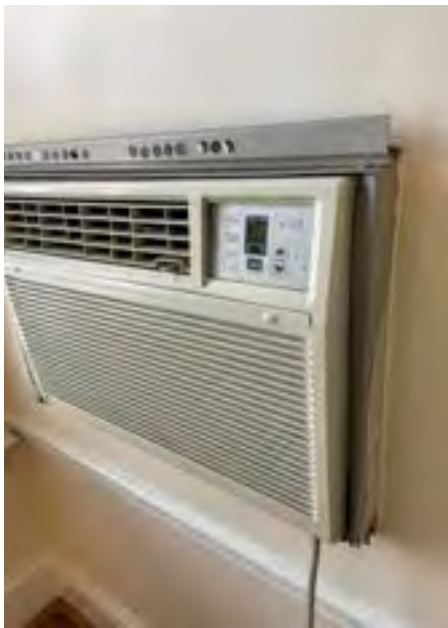
Upper Level Main House A/C: Brand & Data Tag

GE

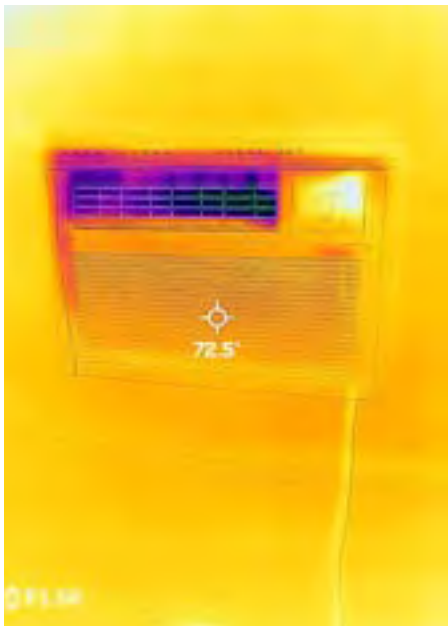
14 Degrees

The temperature differential between the air entering the HVAC system and the return where it exits the HVAC system reflects the effectiveness of the heating and cooling. The temperature differential created by normally operating HVAC systems is between 14° and 22°.

Return 73°

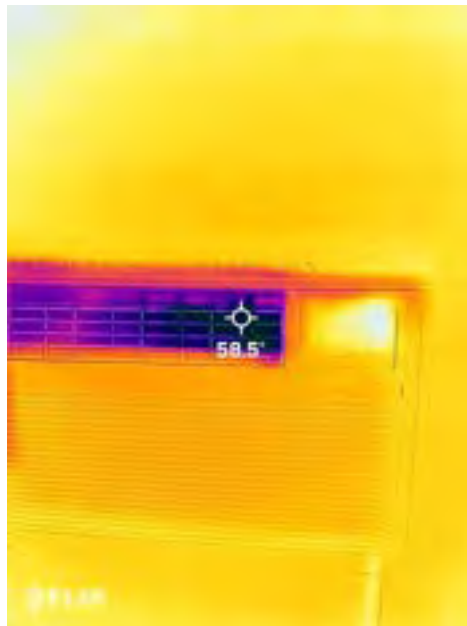
Register 59°

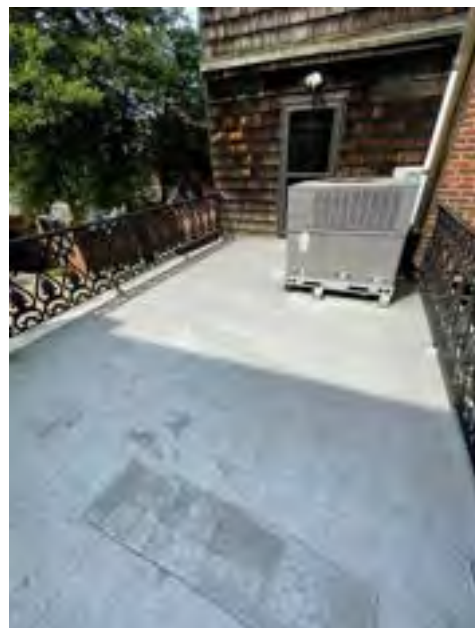
11.3.1 One-Piece HVAC Equipment

INCORRECT ONE-PIECE HVAC SYSTEM TEMPERATURE DIFFERENTIAL

Although the system went through start up procedures and the blower ran, the temperature of the supply air measured at the registers not within operational norms.

A functional HVAC system will create a difference between the temperature of the air where it enters the return duct and the temperature of the air where it exits the supply ducts. That differential should be at least 14 degrees.

Repair or replace the one-piece HVAC system that created an incorrect temperature differential.

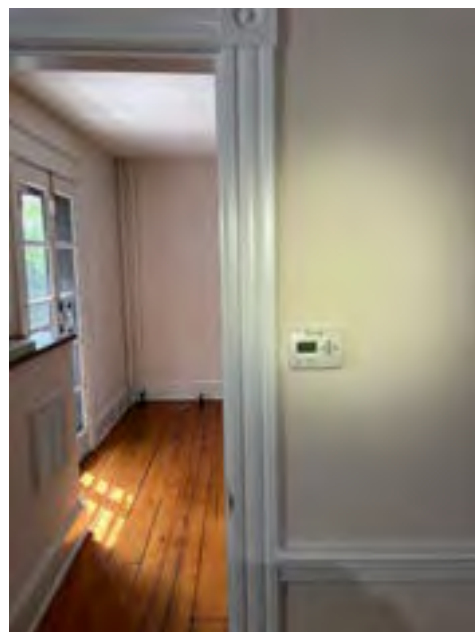
11.4.1 Drainage and Controls

INADVISABLE THERMOSTAT PLACEMENT

The current thermostat orientation will cause inefficient performance of the heating and cooling systems.

Thermostats located on interior walls, away from windows, and away from registers are generally better protected from temperature fluctuations and prevent HVAC system over-activity.

Thermostats in bedrooms--preferably in the primary suite--maintain a more comfortable temperature in bedrooms bedroom at night. Relocating your thermostats will allow you to control the temperature in the home more consistently, comfortably, and effectively.
