**Summer Session of the 25th Navajo Nation Council
July 17, 2023**

**Report on the Navajo Nation Washington Embassy – 11 D Property
Provided by Justin Ahasteen, Executive Director, Navajo Nation Washington Office**

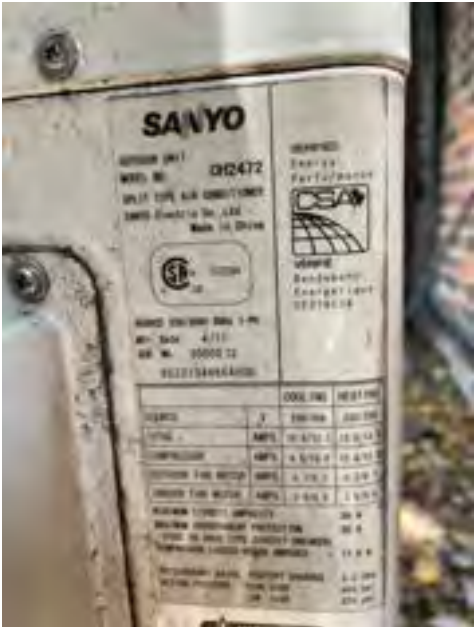
11.7.1 Ductless Heat Pump

INCORRECT DUCTLESS HEAT PUMP TEMPERATURE DIFFERENTIAL

Although the heat pump went through start up procedures and the blower ran, the temperature of the supply air measured at the registers not within operational norms.

A heat pump system is normally considered functional when the operation creates a difference between the temperature of the air where is enters the return duct and the temperature of the air where is exits the supply ducts and when that differential should be at least 14 degrees and should not exceed 22 degrees.

Repair or replace the ductless heat pump that is not creating the appropriate temperature differential.

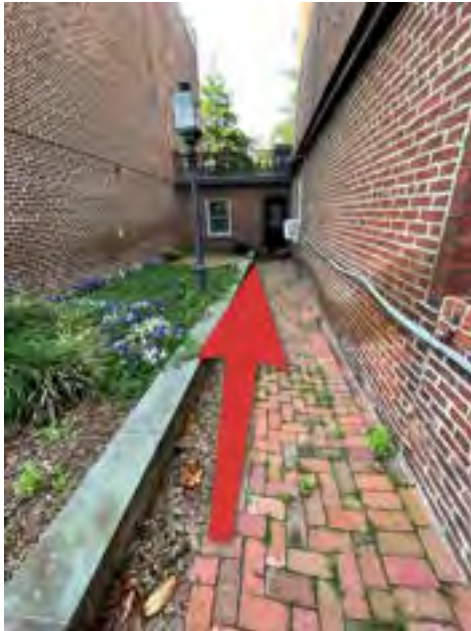
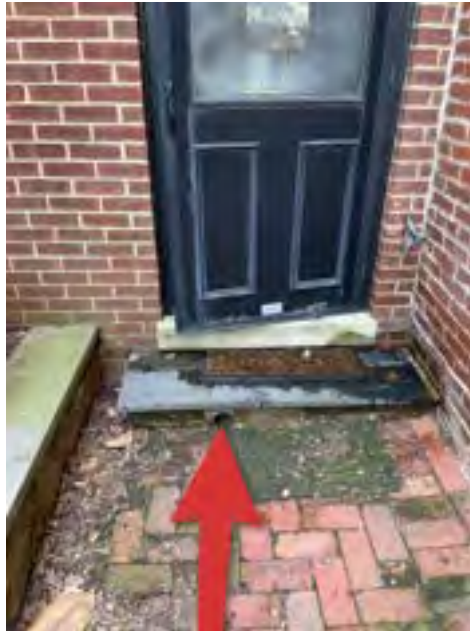
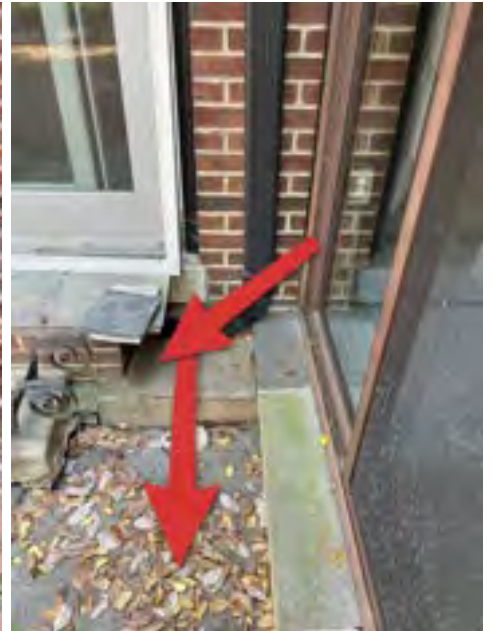
12.2.1 Soil Gas Ventilation, and Flooring Insulation

EXTERIOR DRAINAGE ROUTED THROUGH AN INTERIOR CRAWLSPACE

Consult a general contractor to evaluate the landscaping drainage that appears to have be routed through an inaccessible crawlspace under the ground level addition. This design is highly likely to contribute to mold growth and insect penetration.

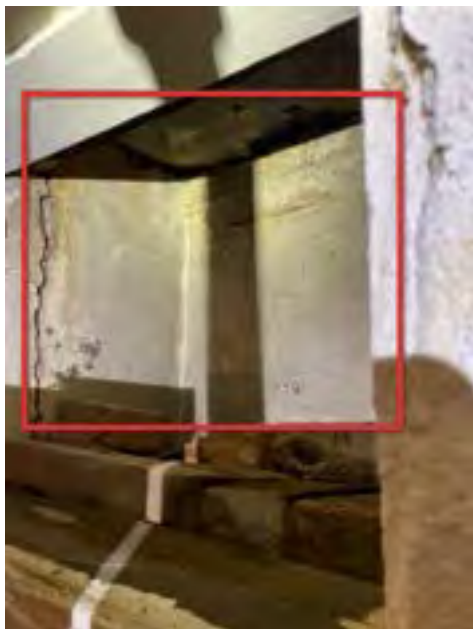
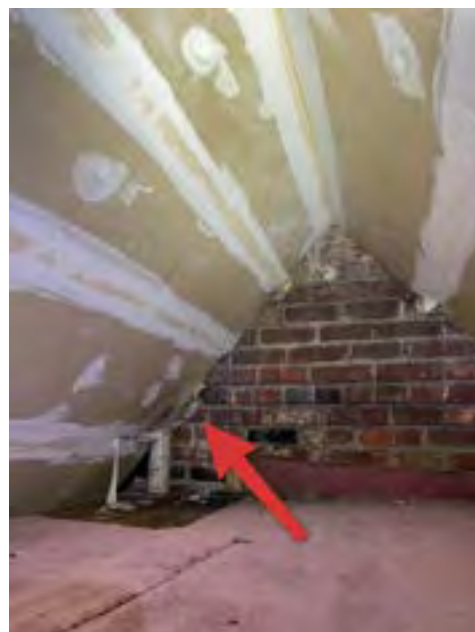
12.4.1 Unfinished Attic Space and Exterior Walls

MISSING ATTIC DEHUMIDIFICATION SYSTEM

Ventilation/dehumidification of the attic is a **CRITICAL FUNCTION** of the attic in your home; it prevents structural damage, roof damage, and mold growth, and it is a critical part of controlling the temperature and humidity levels in your home.

Remediate all mold within the carriage house attic and consult an energy auditor to enact a dehumidification strategy in the attic by installing a ventilation system or complete the installation of an unventilated attic that includes the entire attic within the conditioned thermal envelope of the home.

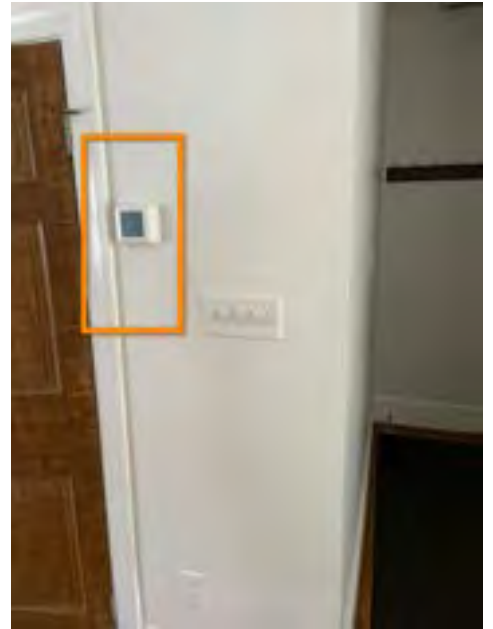
13.4.1 Drainage and Controls

INADVISABLE THERMOSTAT PLACEMENT

Install a smart thermostatic system with several coordinated temperature gauges on all levels of the home or move the thermostat to a position near the center of the living space--preferably close to HVAC returns or the interior wall of the primary bedroom.

Thermostats located on interior walls, away from windows, and away from registers are generally better protected from temperature fluctuations and prevent HVAC system over-activity. Thermostats in bedrooms--preferably in the primary suite--maintain a more comfortable temperature in bedrooms bedroom at night. Relocating your thermostats will allow you to control the temperature in the home more consistently, comfortably, and effectively.

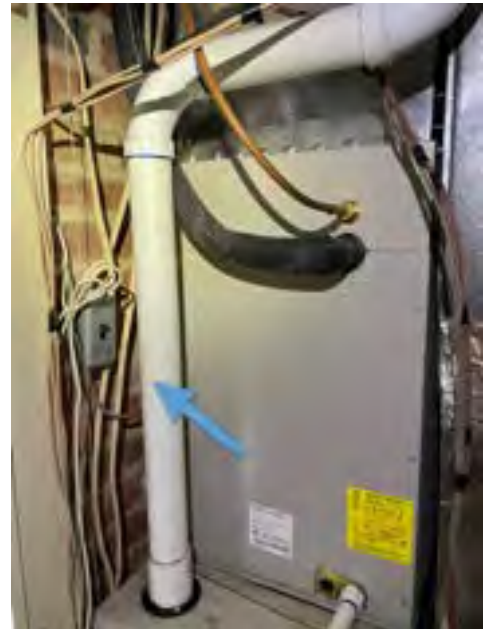
13.4.2 Drainage and Controls

POORLY MARKED MAINTENANCE SHUT-OFF "KILL" SWITCH

Clearly mark the maintenance shut-off "kill" switch in the HVAC closet with a labeled red switch plate cover or one that prevents accidental de-activation of the system.

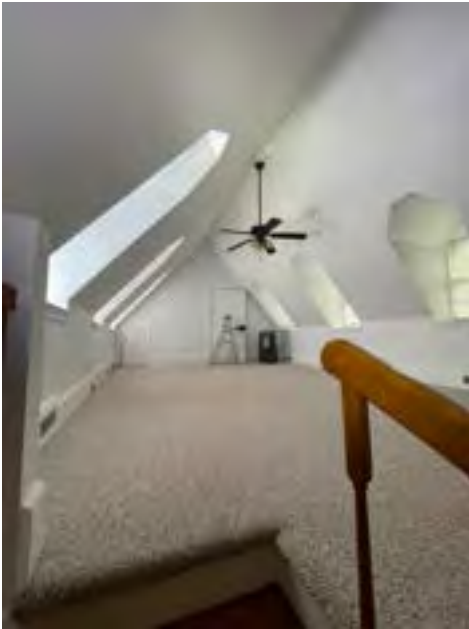
13.5.1 Forced Air Distribution

MISSING RETURN AIR COMPONENTS IN A LEVEL/ZONE

Without both an air return and return ductwork, air will not circulate out of the area, which will pressurize the air in that part of the home. The HVAC system cannot force conditioned air into an overly pressurized room, and as a result the area will be insufficiently heated/cooled and unhealthy conditions may develop due to air stagnancy.

Install a supplemental heating/cooling system or the missing return air components for the area of the home currently only serviced by the HVAC supply system.

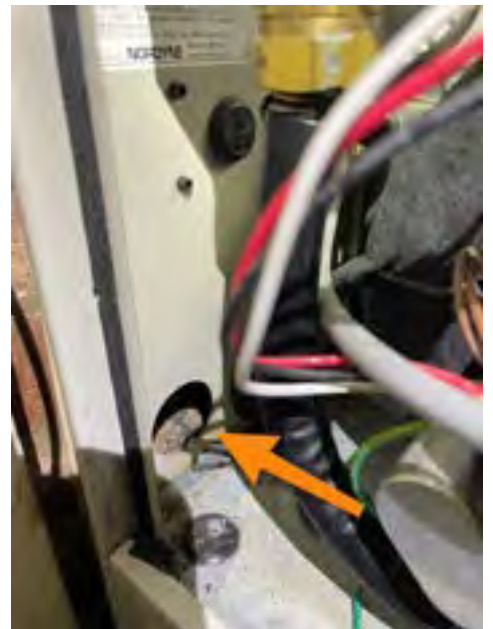
13.6.1 Furnace

OPEN PENETRATIONS IN THE HIGH EFFICIENCY FURNACE COMBUSTION CHAMBER

Open Penetrations

Seal the open penetrations in the combustion chamber for the high efficiency furnace with gaskets or fittings designed for use in furnaces.

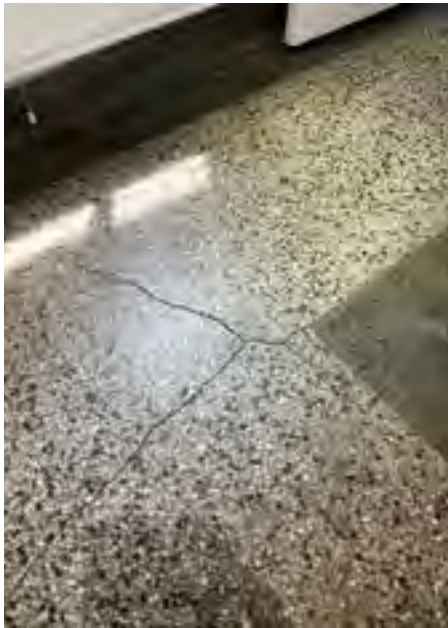
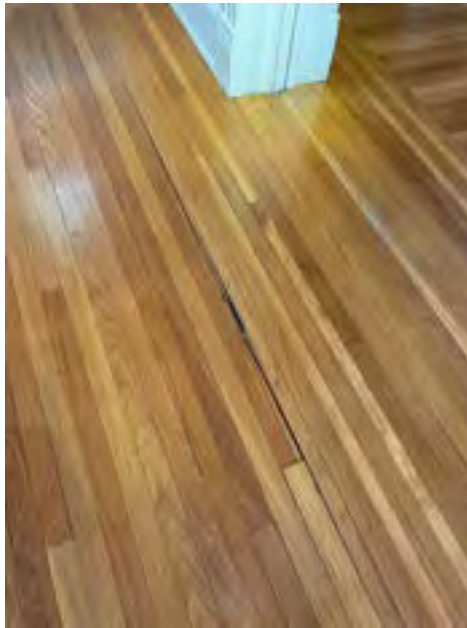
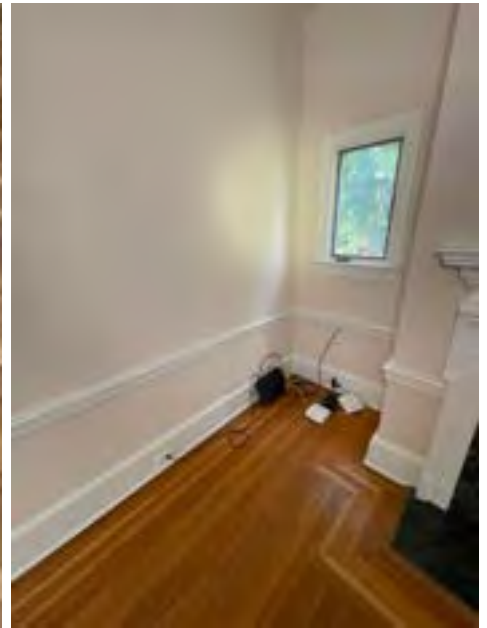
Wall Framing & Floor Bearing: Legacy Sagging Floor

Consult a general contractor to investigate the cause of the sagging floor. This sag appeared to have been a long-standing feature of the home.

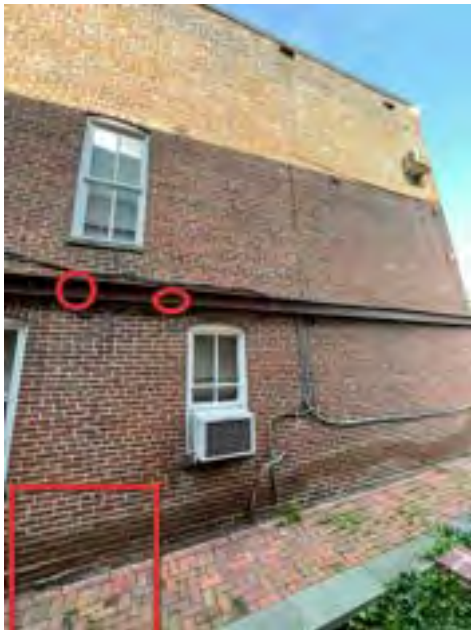
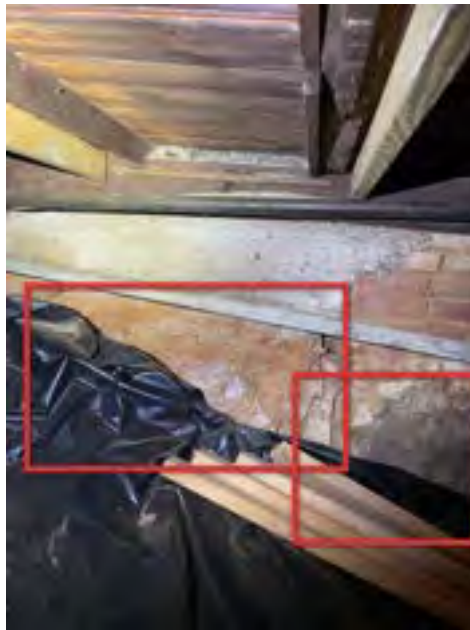
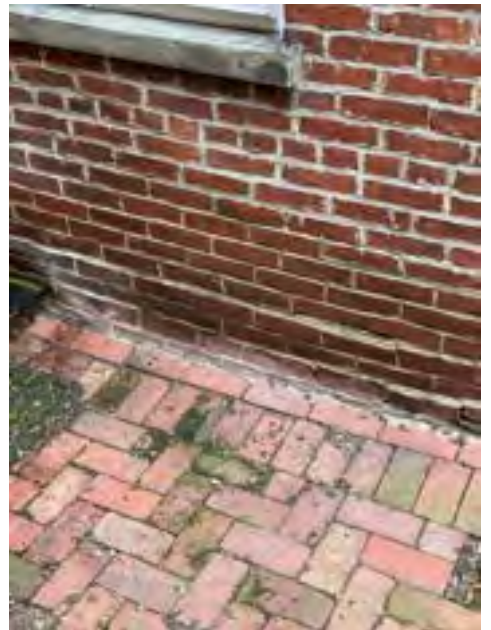
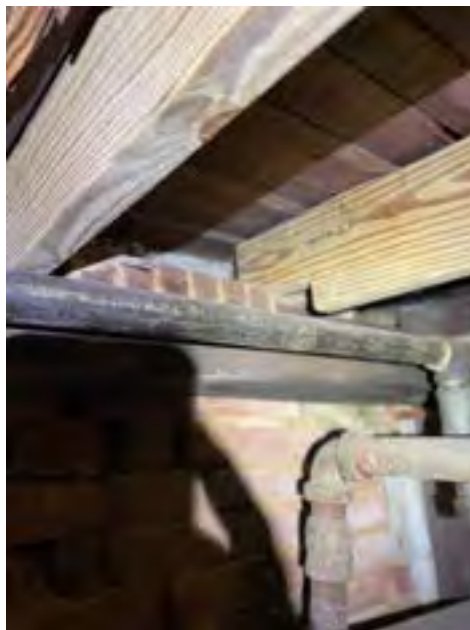
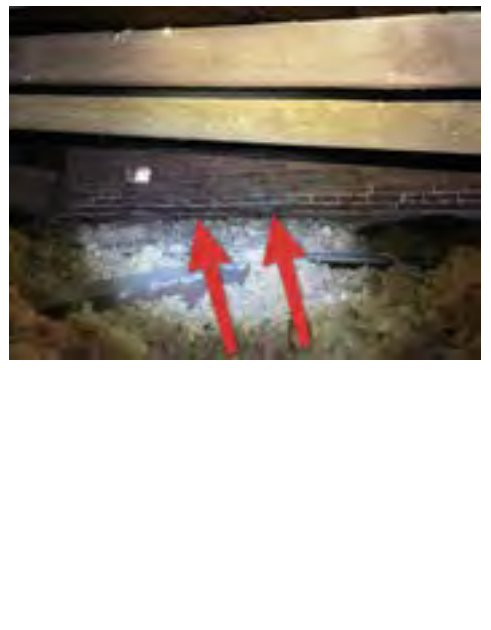
14.2.1 Perimeter Foundation

EXCESSIVE FOUNDATION MOVEMENT

From the exterior, rows of bricks which have been recently repaired appear to have pulled away from the wall.

from within the attic, sagging is visible in the masonry wall

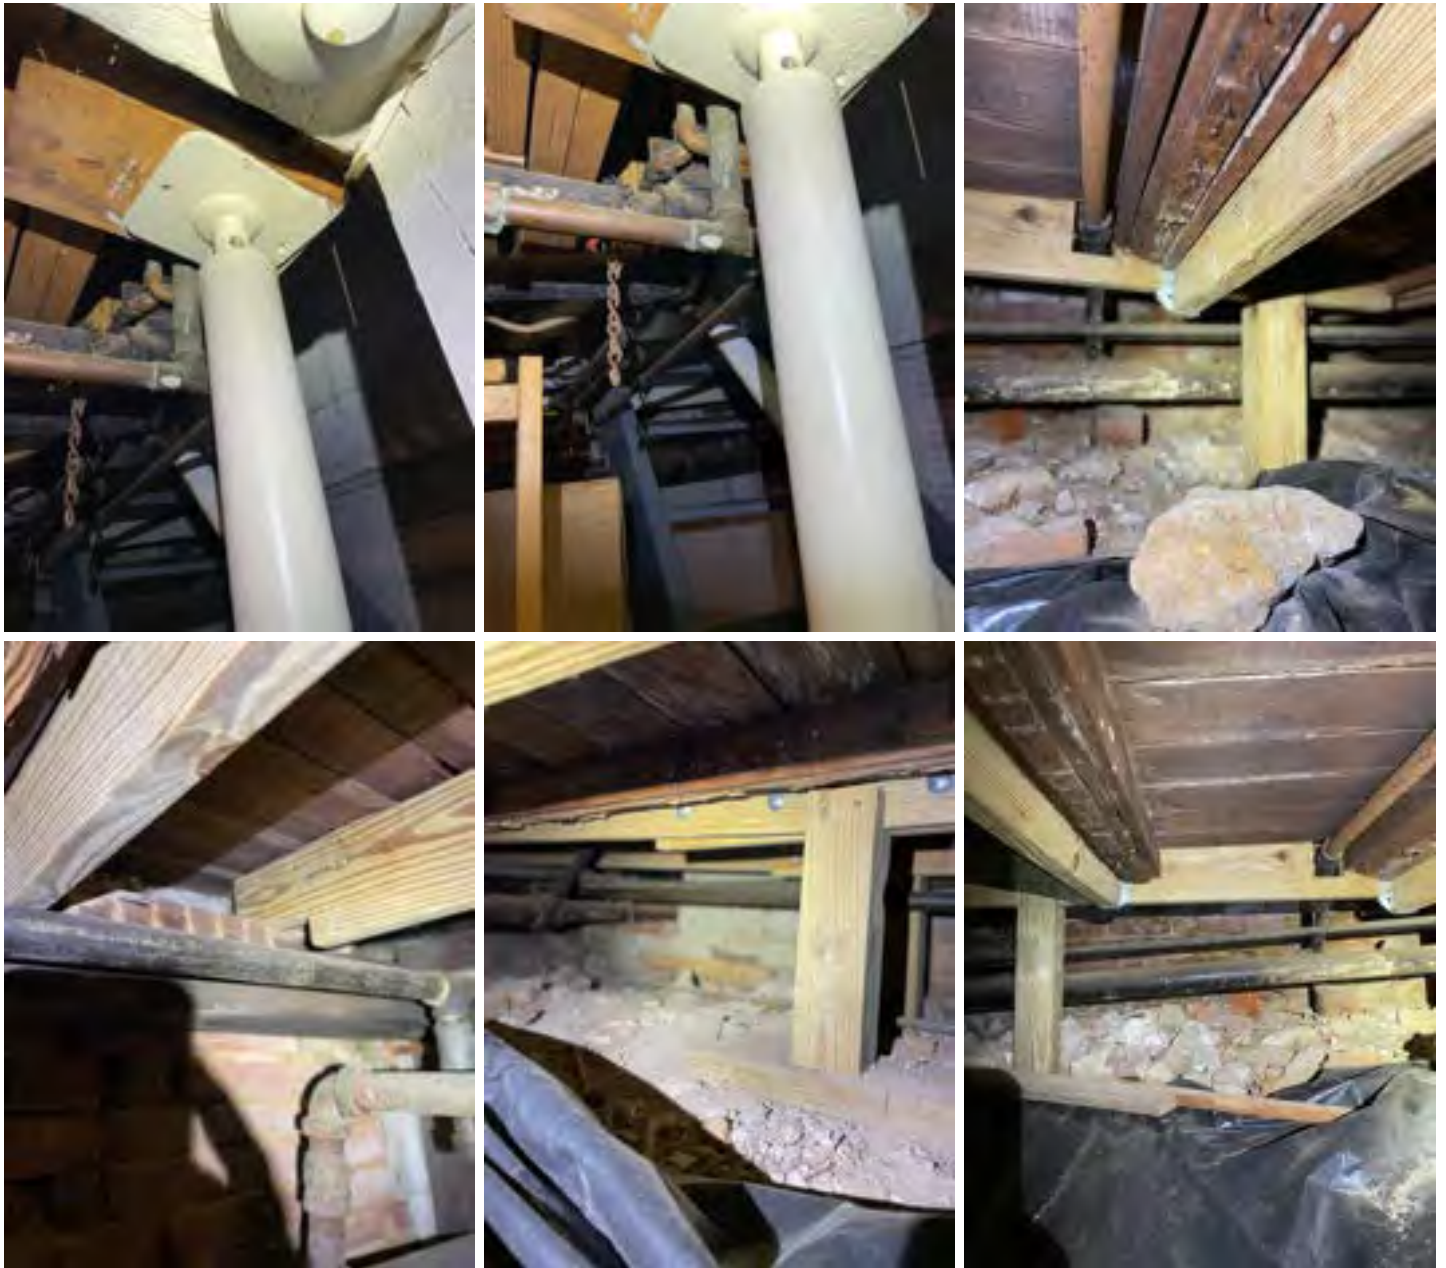
14.2.2 Perimeter Foundation

ATYPICAL SUPPLIMENTAL STRUCTURAL SUPPORT DESIGN

The terrazzo flooring about these modifications appears to suffer from rapid degradation. The upper levels of the home have similar symptoms, which may suggest that there is extensive termite damage that has not been repaired.

I recommend AGAINST OCCUPYING THE HOME until a structural study or evaluation can be carried out on all levels of the home.

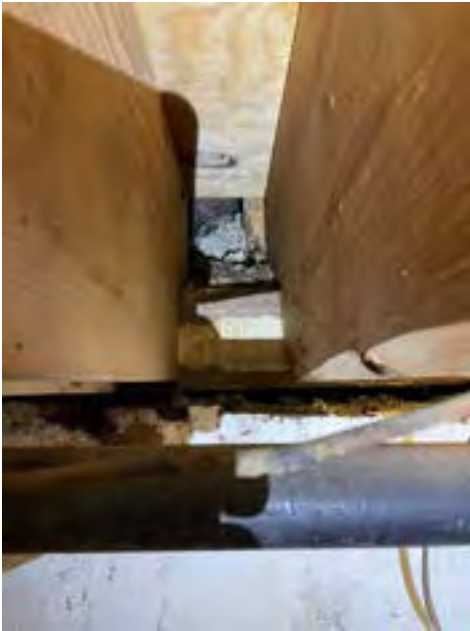
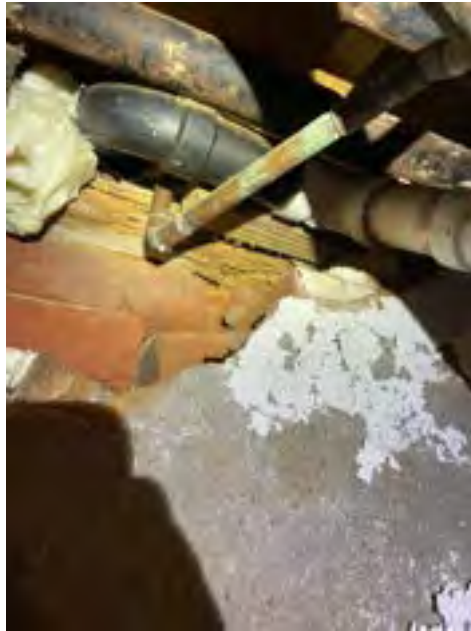
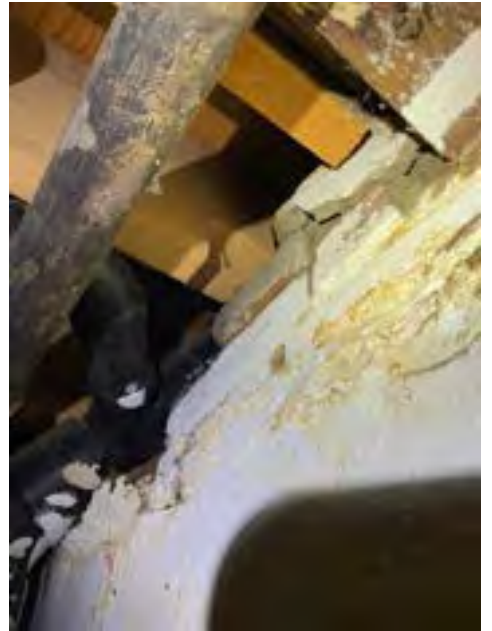
14.2.3 Perimeter Foundation

Several locations of structural deterioration appeared to be present in areas around the rear home, beyond the apparent edge of the foundation wall, visible from the basement. These locations need evaluation.

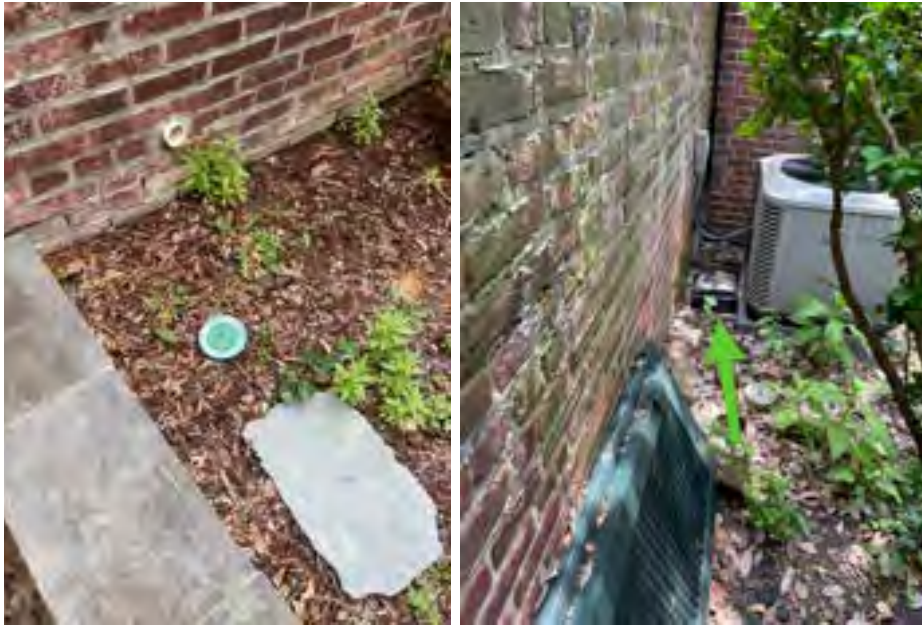
Termite Abatement Traps, Rat Boxes

These pest prevention measures appear to be present at the property, and should be maintained and kept active. I cannot determine if they are currently active or effective, and a pest control expert should be consulted.

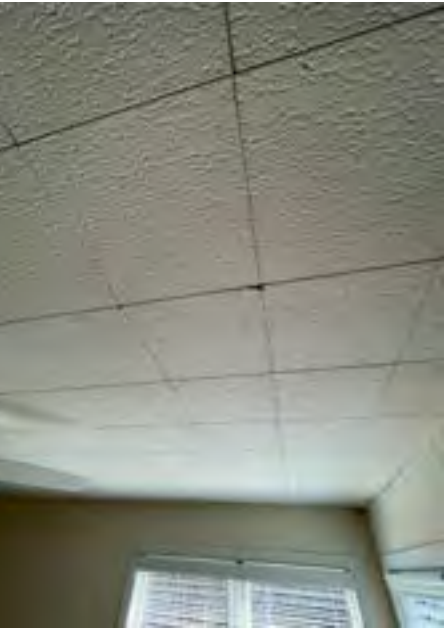
The home appears to contain a layer of asbestos-acoustic ceiling tile.

Before removing or handling the tiles, consult an asbestos-removal contractor regarding effective hazardous material protection, such as encapsulation or remediation.

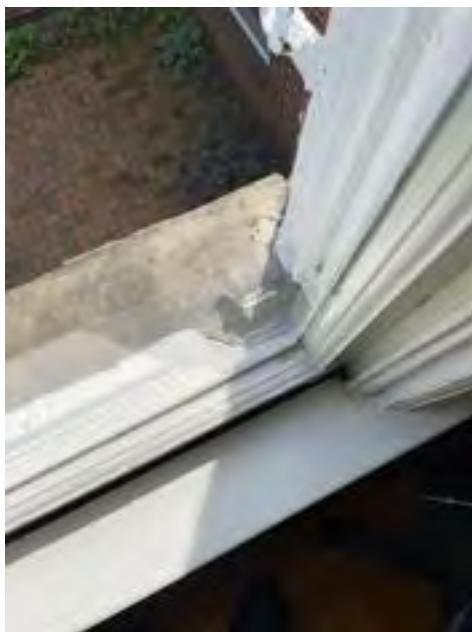
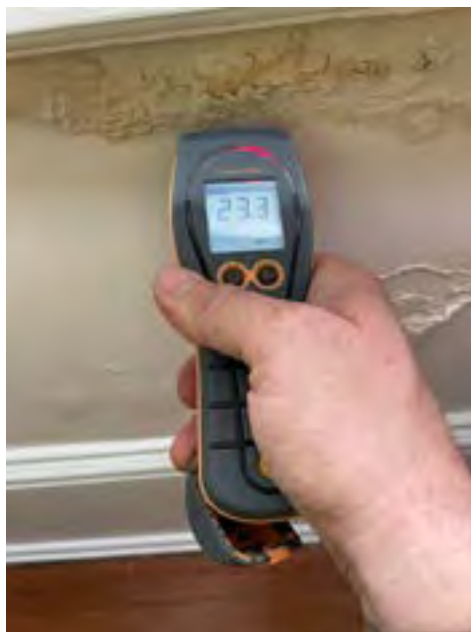
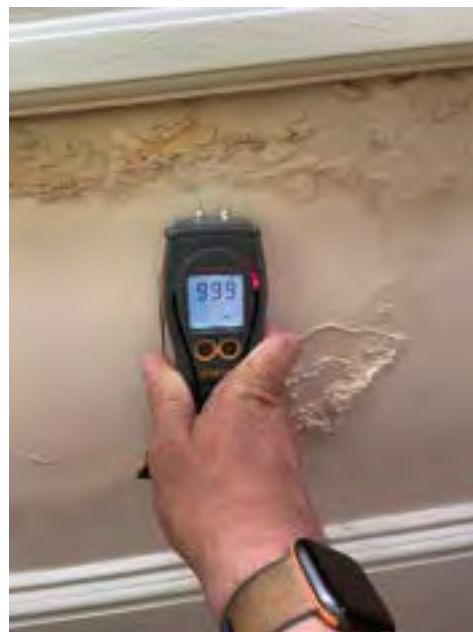
17.3.3 Doors and Windows

LEAKY AND GAMED WINDOW SILL

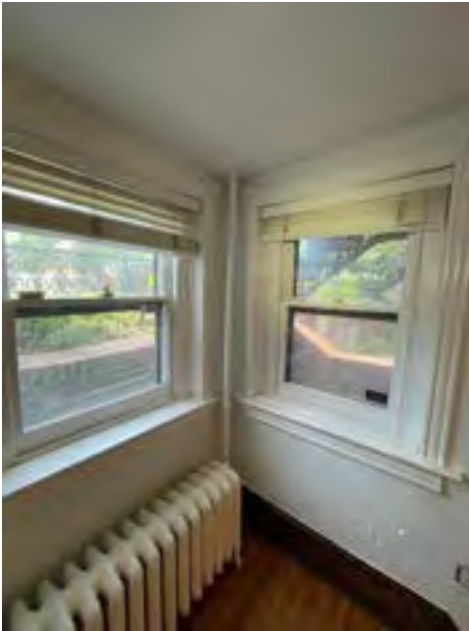
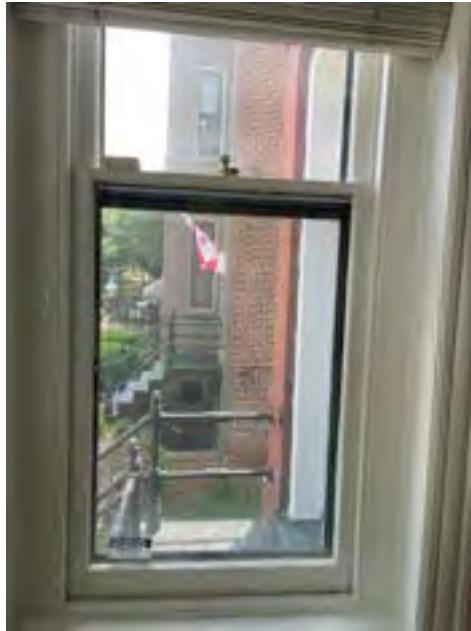
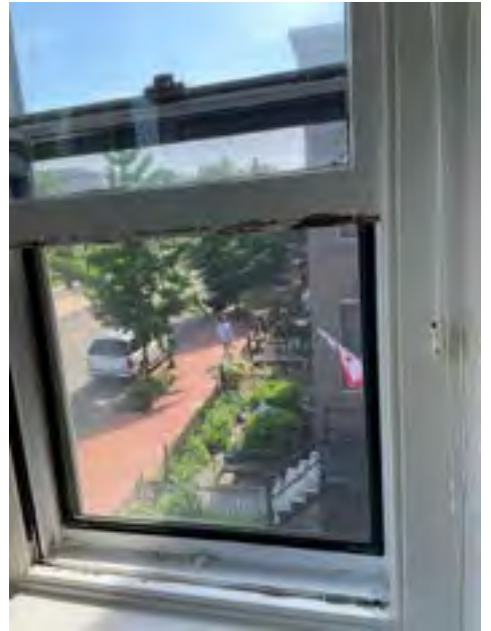
17.3.4 Doors and Windows

PAINTED SHUT WINDOWS

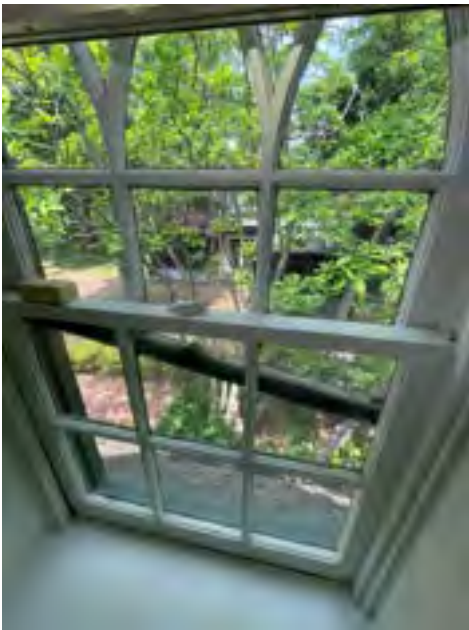
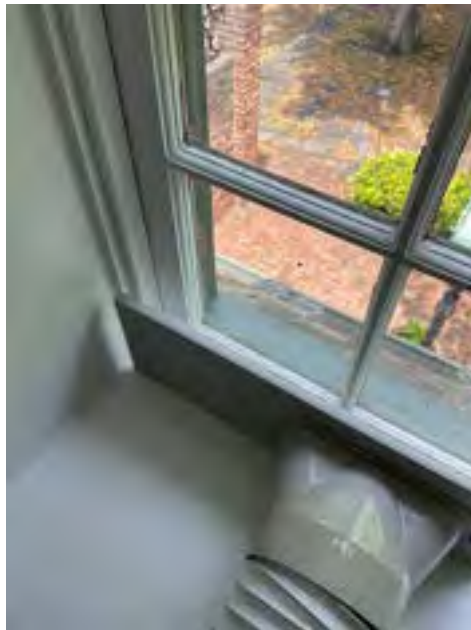
17.3.5 Doors and Windows

DAMAGED WINDOW SASH

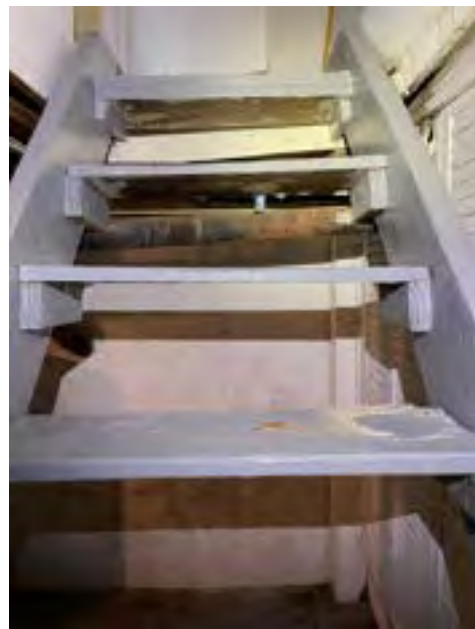
17.5.3 Stairways and Railings

NON-STANDARD INTERIOR STAIRWAY DIMENSIONS

Modify the interior stairs that have non-standard dimensions so that the stairs are level and also have both consistent riser heights and tread depths in order to prevent tripping.

Although stairs should be installed consistent with the specific guidance from your municipality, generally stair treads should be level and should be at least 36" wide and 10" deep, risers should be between 4" and 7 3/4" high, there should not be a height difference between risers or depth difference in treads in excess of 3/8", and the resulting slope of the stair should not be more than 42 degrees from the level of the ground. A landing should be present on every staircase for at least every 12 vertical feet.

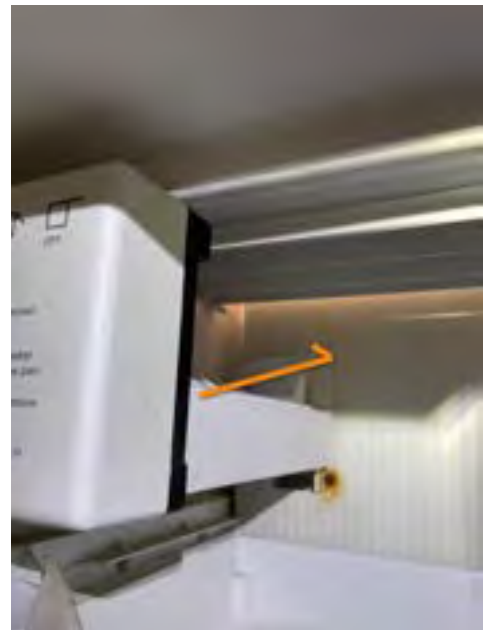
18.2.2 Refrigerator/Freezer

NON-FUNCTIONAL ICE MAKER

The ice maker did not make ice during the inspection; verify that there is a functioning water supply to the fridge and that the ice maker works.

Correct the built-in ice maker.

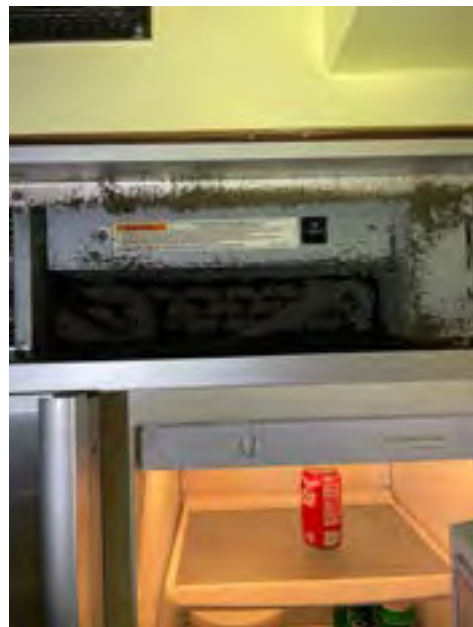
18.2.3 Refrigerator/Freezer

DIRTY REFRIGERATOR COILS

Normal Maintenance

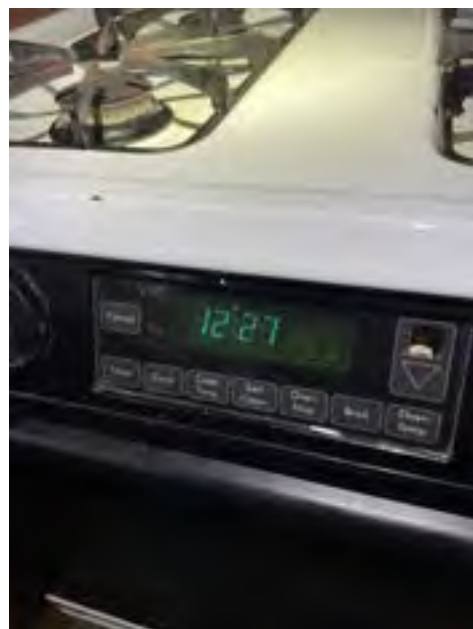
18.4.1 Range Oven or Cooktop

DAMAGED CONTROL PAD

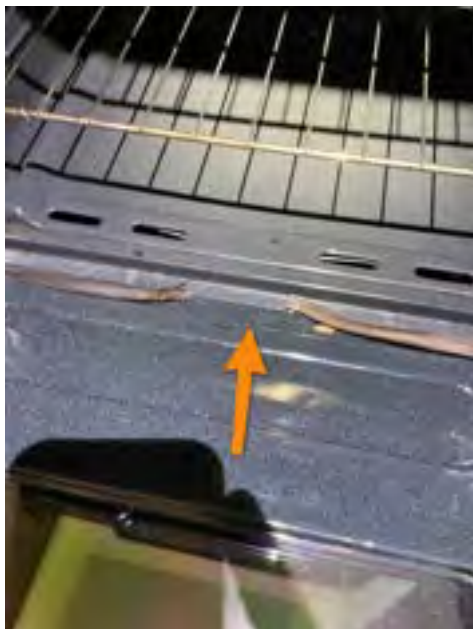
18.4.2 Range Oven or Cooktop

DETERIORATED DOOR GASKET

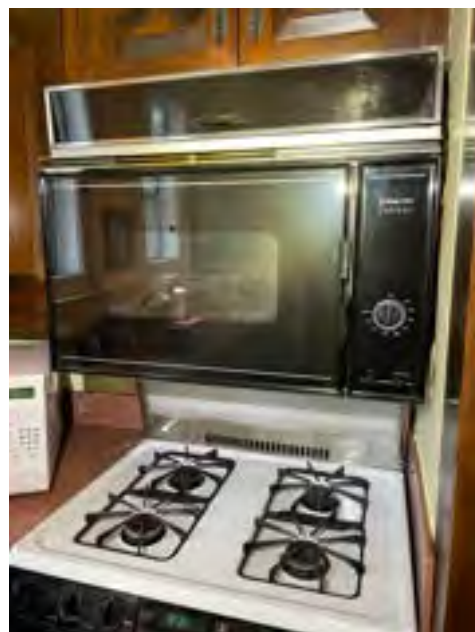
18.6.1 Microwave Cooking Equipment

NON-FUNCTIONAL MICROWAVE

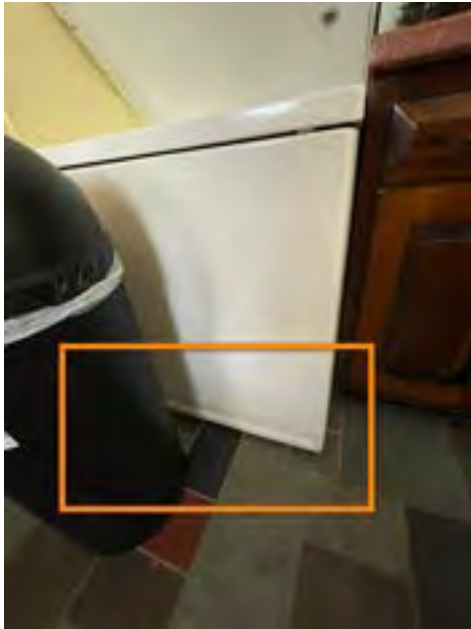
18.9.1 Clothes Washer

MISSING CLOTHES WASHING MACHINE DRIP PAN

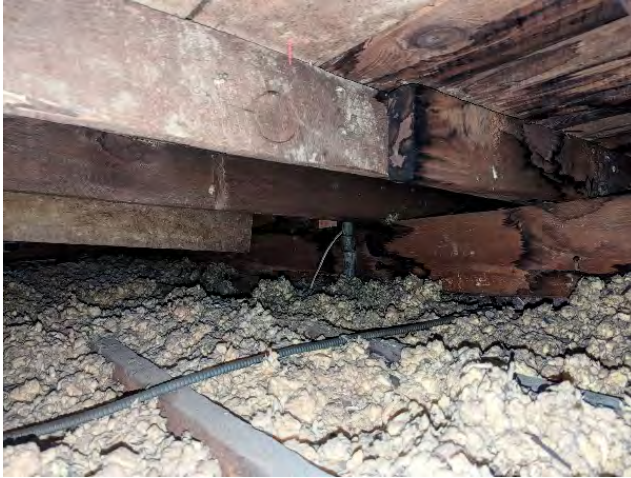
Photo 1 - Split/Failed Roof Girder

- 1. The initial survey and analysis of the property revealed several alarming structural issues. Notably, the east-west timber roof girder is split, and its west end bearing is side-nailed to vertical wood studs, resulting in a significant loss of structural capacity. Additionally, the northern roof girder may not be fully bearing on the existing brick wall due to partially rotated loose bricks. These

In addition to sizing the girder correctly, this analysis effort would determine an existing roof capacity that could be used to verify code compliance and provide guidance for any future modifications or additions to the roof.

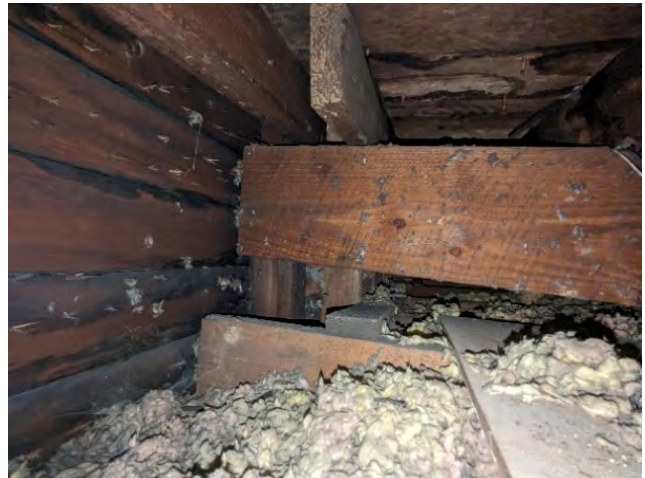
Photo 4 - Roof Girder Bearing at West End

Additionally, the west end bearing, see Photo 4, doesn't appear to bear directly on any exterior wall framing, but is rather side-nailed to vertical wood studs. It was unclear during our inspection what was supporting the vertical wood studs.

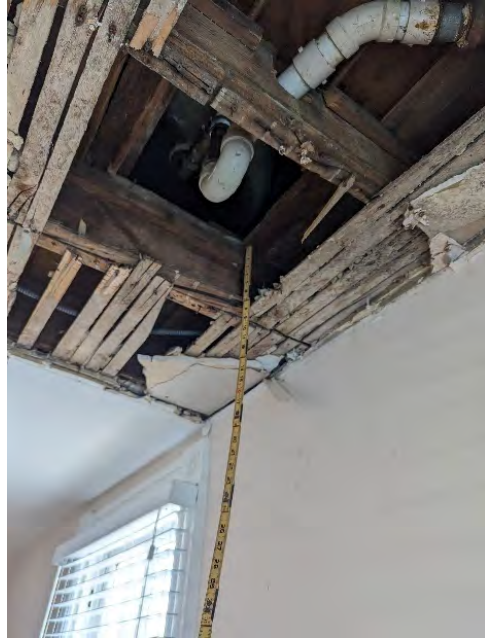
Photo 7 – Second Floor Plumbing Notches in (E) Wood Joists

Observed in this damaged area of the second-floor framing, plumbing fixtures were installed at some point after the installation of the wood joist framing and, while doing so, the wood joists were cut and notched to install the piping for the fixtures. The notching is significant at two locations and shown in Photo 6 and Photo 7.

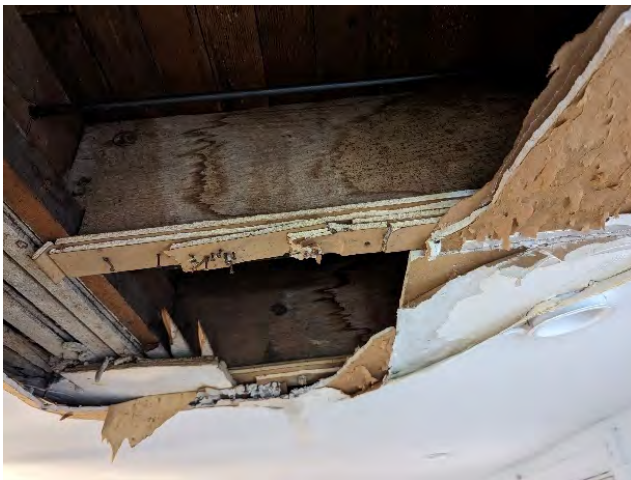
Photo 8 – Multiple Layers of Gypsum Board on Ceiling

Additionally, we observed up to four layers of gypsum board at the ceiling resulting in a higher dead load than typical for residential construction, see Photo 8. This could impact the floor capacity of all of the existing joists.

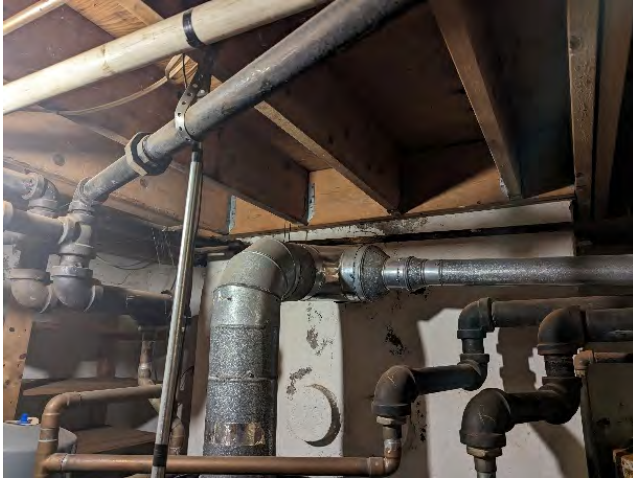
Photo 9 – Basement Header Framing

3. In the basement, the connection between the double header and double joists appears inadequate, and the double joists are not sistered together along their length. The same deficiency extends to the crawl space, where supplemental framing exhibits numerous deficiencies. Therefore, it is recommended that the floor framing be analyzed to verify its capacity to support commercial floor loading, with additional reinforcement as needed.

Additionally, at a minimum, sistering of the existing double joists should be performed and reinforcing of the connection between the double header and double joist will be required. The connection repair may require temporary shoring and removal of framing elements to allow for the installation of a properly engineered hanger connection.

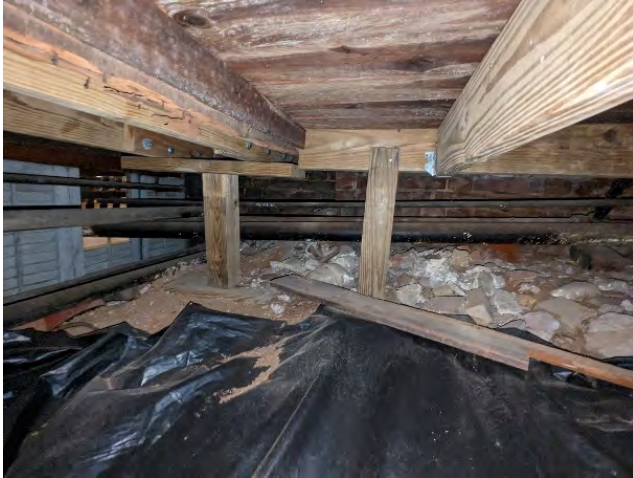
Photo 13 – Crawl Space Framing

5. The crawl space framing has significant deficiencies in the framing, connections, bracing, and support elements. The framing sections do not appear to be appropriately sized and improperly installed. The recommendation for this fix requires a complete reframe and modification to the foundation in order to be in compliance with the appropriate building codes for the District of Columbia.

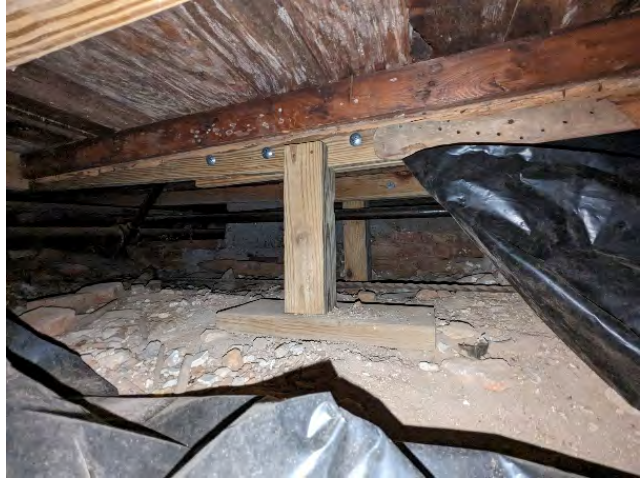
Photo 14 – Crawl Space Framing

Supplemental framing was added to strengthen the existing first floor framing in the central and northern sections of the property. This supplemental framing, shown in Photo 13 through Photo 16, has numerous deficiencies in the framing, connections, bracing, and support elements. More specifically, framing sections don't appear to be appropriately sized, connections are improperly sized or not correctly installed, stability and bracing wasn't apparent, and support/foundation elements are supported on loose dirt.

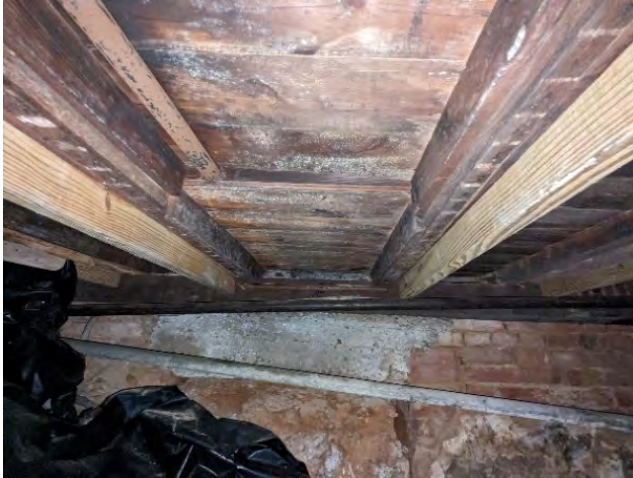
Photo 17 – East Side Foundation Header

4. The basement foundation also shows substantial deterioration, particularly in the parging and mortar. Waterproofing the below-grade foundation wall and/or damp proofing the brick bearing wall could address this issue. However, the exterior east wall presents more severe problems. It is bowing outwards both horizontally and vertically, necessitating further evaluation and possibly destructive analysis.

Moisture will continue to deteriorate the existing brick, mortar, and parging. Solutions to resolve these issues will be required that may include waterproofing of the below grade foundation wall and/or damp proofing of the brick bearing wall. Subsequent repointing of the existing brick walls will likely be required.

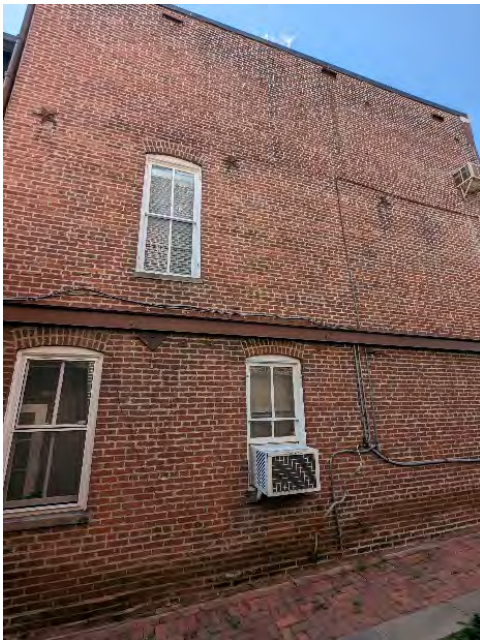
Photo 22 – Horizontal Steel Channel – East Side

We also observed two tie-rods that were installed connecting the east and west exterior walls between the horizontal steel channels. These locations are roughly located between the three windows shown on *Photo 22*. These rods were observed to still be tensioned, indicating they were still providing bracing as originally designed. *Photo 23* shows the rod penetrating through the exterior wall but also indicates a horizontal wood course in the brick, located to the right of the rod penetration.

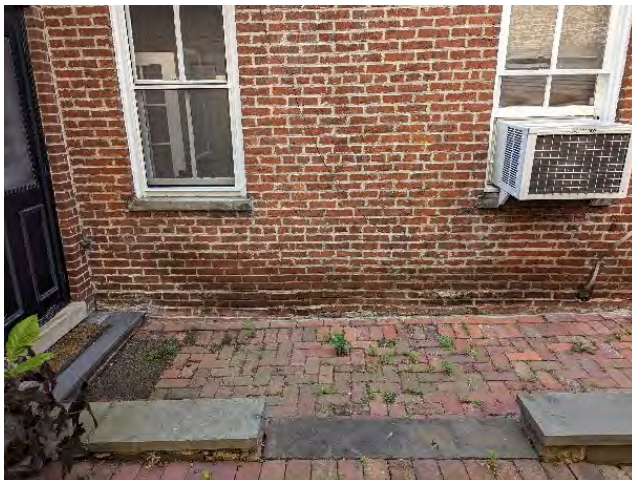
Photo 24 - Moisture in West Exterior Wall

6. Moreover, there is apparent water staining along the east wall, suggesting a rising damp issue. Similarly, the east wall's mortar has debonded from the existing brick, with gaps and voids in the bed joints being significant. A comprehensive approach for the restoration of the bearing walls, including a mortar analysis, is therefore recommended.

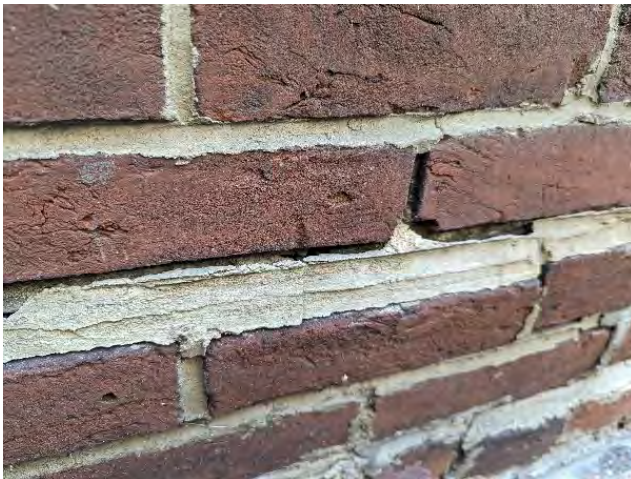
Photo 28 – Separation of New Mortar

The east wall has been repointed and, in several areas, the mortar of the wall joints has de-bonded from the existing brick, exposing the existing mortar behind. We observed this mortar to be significantly deteriorated, see Photo 26 through Photo 29.

Gaps and voids in the bed joints were significant, see Photo 27 and Photo 29. We also observed the new mortar seemed significantly stronger than any of the existing mortar.

b. Recommended Actions:
